Left Plot w/ Pics

| Pipe ID L13-5 | City | Street CLOVER LN 2210 E | Shape | Map #1 | Basin |
| US Manhole L13-5 | Section Length 72.022 | Year Laid | Material CON | Section Type | |
| DS Manhole L13-4 | Inspected Length 284.4 | Year Renewed | Depth US 9.8 | Depth DS | Joint Leng... Diameter 8 |

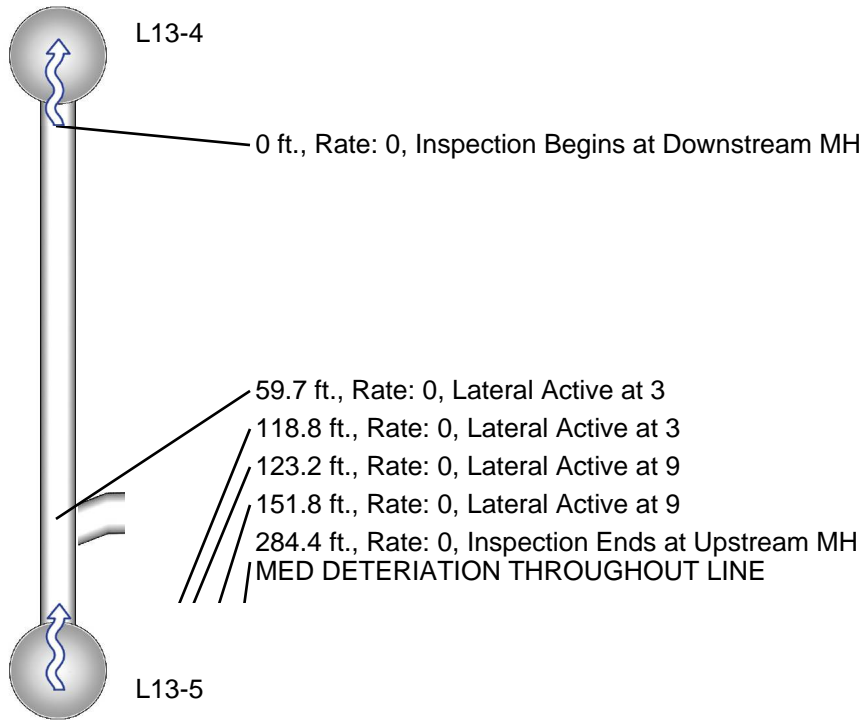
| Code: CLV | 59.7 ft. | 3 | | | |
| Observation: Lateral Active | | | | | |

| Code: CLV | 118.8 ft. | 3 | | | |

| Code: CLV | 123.2 ft. | 9 | | | |

| Code: CLV | 151.8 ft. | 9 | | | |

| Remarks: MED DETERIATION THROUGHOUT LINE | | | | | |
