Left Plot w/ Pics

Pipe ID N120-183	City	Street WREN RD 4850 S	Shape	Map #1	Basin
US Manhole N120-183	Section Length 68.377	Year Laid	Material CON	Section Type	
DS Manhole N120-180	Inspected Length 215.6	Year Renewed	Depth US 9	Depth DS	Joint Leng... Diameter 8
Cleaned		Situation		Reason	
Date 20181019	Clean Date	Weather		Remark	
Start Time 11:15					
Operator CODY	Customer	Truck 4161	Inspection Dir. Downstream	Info	
Operator Comment	P.O. Number	Present	Flow Control	Camera

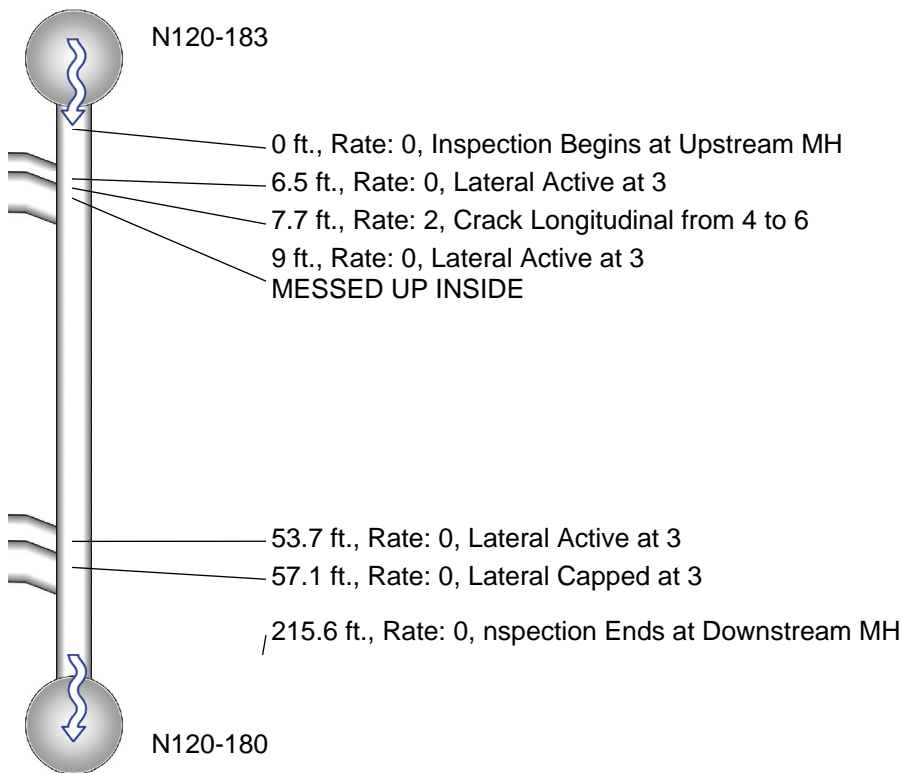
Scaled Plot

Code: CLV	6.5 ft.	3				
Observation: Lateral Active							
Remarks:

Code: YCL	7.7 ft.	4 - 6				
Observation: Crack Longitudinal							
Remarks:

Code: CLV	9.0 ft.	3				
Observation: Lateral Active							
Remarks: MESSED UP INSIDE

Code: CLV	53.7 ft.	3				
Observation: Lateral Active							
Remarks:

Code: CLC	57.1 ft.	3				
Observation: Lateral Capped							
Remarks:
