Left Plot w/ Pics

Pipe ID L5-1	City	Street ALBRIGHT DR 2070 E	Shape	Map #1	Basin
US Manhole L5-1	Section Length 73.031	Year Laid	Material	Section Type	
DS Manhole L5	Inspected Length 251.5	Year Renewed	Depth US 7.5	Depth DS	Joint Leng... Diameter 10
Cleaned		Situation		Reason	
Date 20181126	Clean Date	Weather		Remark	
Start Time 10:49					
Operator MIKE	Customer	Truck 4161	Inspection Dir. Downstream	Info	
Operator Comment	P.O. Number	Present	Flow Control	Camera

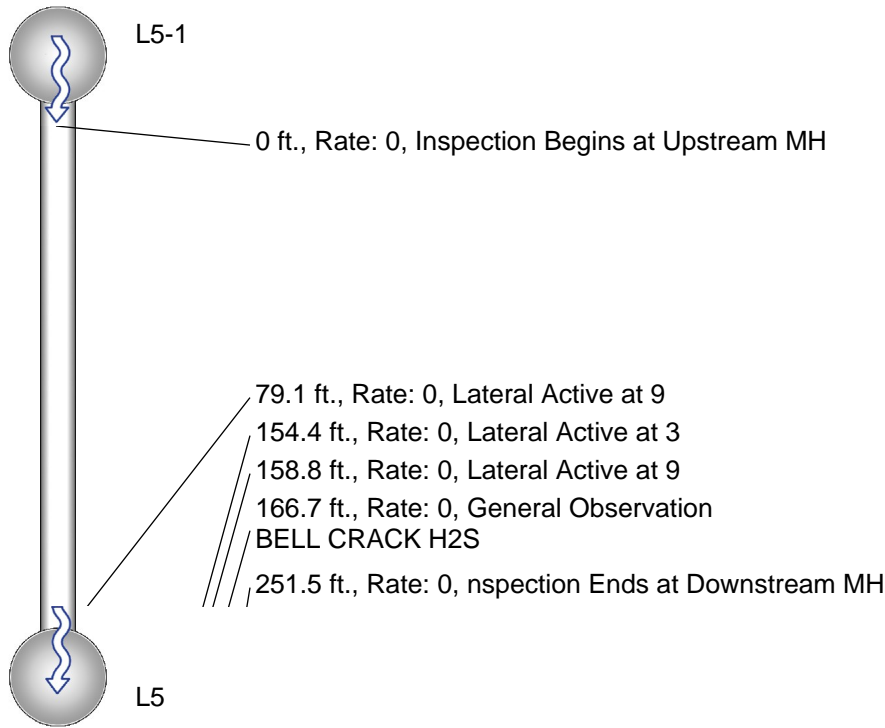
Code: TGO 166.7 ft. Observation: General Observation
Remarks: BELL CRACK H2S
