Left Plot w/ Pics

Pipe ID L12-1	City	Street CUMBERLAND RD 2145 ...	Shape	Map #1	Basin
US Manhole L12-1	Section Length 103.948	Year Laid	Material CON	Section Type	
DS Manhole L12	Inspected Length 342.3	Year Renewed	Depth US 3.5	Depth DS	Joint Leng... Diameter 10
Cleaned	Situation		Reason		
Date 20170303	Clean Date	Weather		Remark	
Start Time 09:05					
Operator MIKE	Customer	Truck 4165	Inspection Dir. DOWNSTREAM	Info	
Operator Comment	P.O. Number	Present	Flow Control	Camera

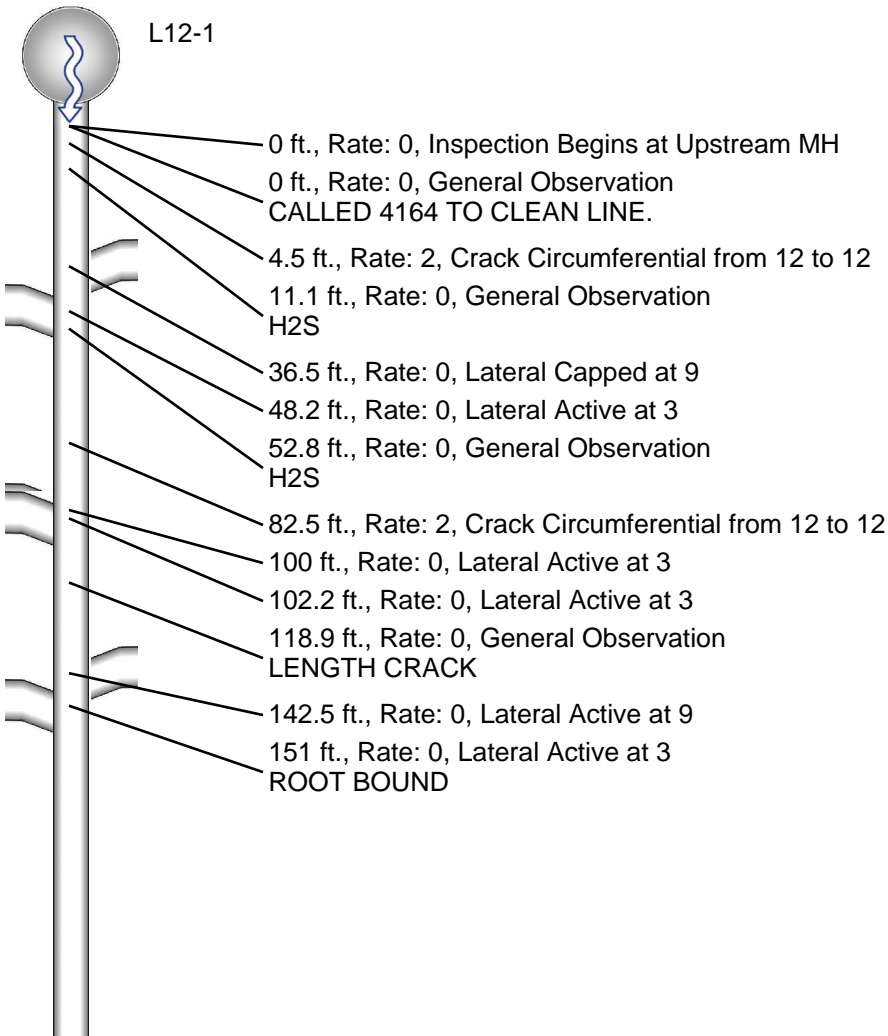
Scaled Plot

Code: TIBU	0.0 ft.				
Observation: Inspection Begins at Upstream MH					
Remarks:

Code: TGO	0.0 ft.				
Observation: General Observation					
Remarks: CALLED 4164 TO CLEAN LINE.

Code: YCC	4.5 ft.	12 - 12			
Observation: Crack Circumferential					
Remarks:

Code: TGO	11.1 ft.				
Observation: General Observation					
Remarks: H2S

Code: CLC	36.5 ft.	9			
Observation: Lateral Capped					
Remarks:

Code: CLV	48.2 ft.	3			
Observation: Lateral Active					
Remarks:

Code: TGO	52.8 ft.				
Observation: General Observation					
Remarks: H2S

Code: YCC	82.5 ft.	12 - 12				
Observation: Crack Circumferential							
Remarks:							
 	Code: CLV	100.0 ft.	3				
Observation: Lateral Active							
Remarks:							
 	Code: CLV	102.2 ft.	3				
Observation: Lateral Active							
Remarks:							
 	Code: TGO	118.9 ft.					
Observation: General Observation							
Remarks: LENGTH CRACK							
 	Code: CLV	142.5 ft.	9				
Observation: Lateral Active							
Remarks:							
 	Code: CLV	151.0 ft.	3				
Observation: Lateral Active							
Remarks: ROOT BOUND							
 	Code: CLV	256.7 ft.	3				
Observation: Lateral Active							
Remarks:							
 	Code: TGO	258.1 ft.					
Observation: General Observation							
Remarks: ROOTS

Code: CLV	261.6 ft.	3				
Observation: Lateral Active						
Remarks:

Code: TIED	342.3 ft.					
Observation: nspection Ends at Downstream MH						
Remarks: H2S. HAD 4164 REMOVE ASPHALT
