Left Plot w/ Pics

Pipe ID E12-1	City	Street 1100 E	Shape	Map #1	Basin
US Manhole E12-1	Section Length 105.5	Year Laid	Material CON	Section Type	
DS Manhole E12	Inspected Length 310.1	Year Renewed	Depth US 10	Depth DS	Joint Leng... Diameter 10
Cleaned	Situation		Reason		
Date 20170831	Clean Date	Weather		Remark	
Start Time 11:00					
Operator STEVEN	Customer	Truck 4165	Inspection Dir. DOWNSTREAM	Info	
Operator Comment	P.O. Number	Present	Flow Control	Camera

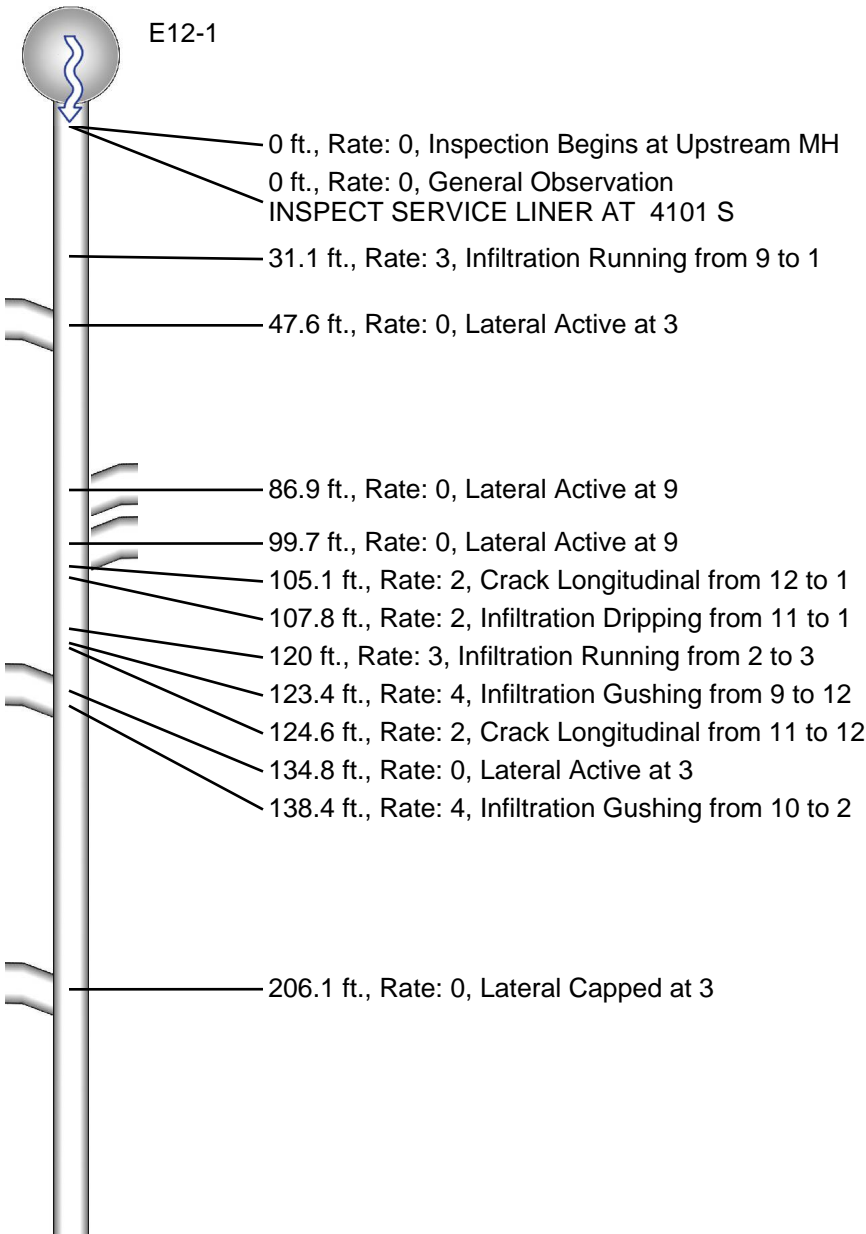
Code: MIR	31.1 ft.	9 - 1			
Observation: Infiltration Running					
Remarks:

Code: YCL	105.1 ft.	12 - 1			
Observation: Crack Longitudinal					
Remarks:

Code: MID	107.8 ft.	11 - 1			
Observation: Infiltration Dripping					
Remarks:

Code: MIR	120.0 ft.	2 - 3			
Observation: Infiltration Running					
Remarks:

Code: MIG	123.4 ft.	9 - 12			
Observation: Infiltration Gushing					
Remarks:

Code: YCL	124.6 ft.	11 - 12			
Observation: Crack Longitudinal					
Remarks:

Code: MIG	138.4 ft.	10 - 2			
Observation: Infiltration Gushing					
Remarks:

Remarks: SERVICE LINER LOOKED GOOD / CRACKS / I/I
