Left Plot w/ Pics

Pipe ID N120-36	City	Street VALLEY VIEW AVE 481...	Shape	Map #1	Basin
US Manhole N120-36	Section Length 63.302	Year Laid	Material CON	Section Type	
DS Manhole N120-35	Inspected Length 236.6	Year Renewed	Depth US 13	Depth DS	Joint Leng... Diameter 8
Cleaned		Situation		Reason	
Date 20181022	Clean Date	Weather		Remark	
Start Time 11:03					
Operator CODY	Customer	Truck 4161	Inspection Dir. Downstream	Info	
Operator Comment	P.O. Number	Present	Flow Control	Camera

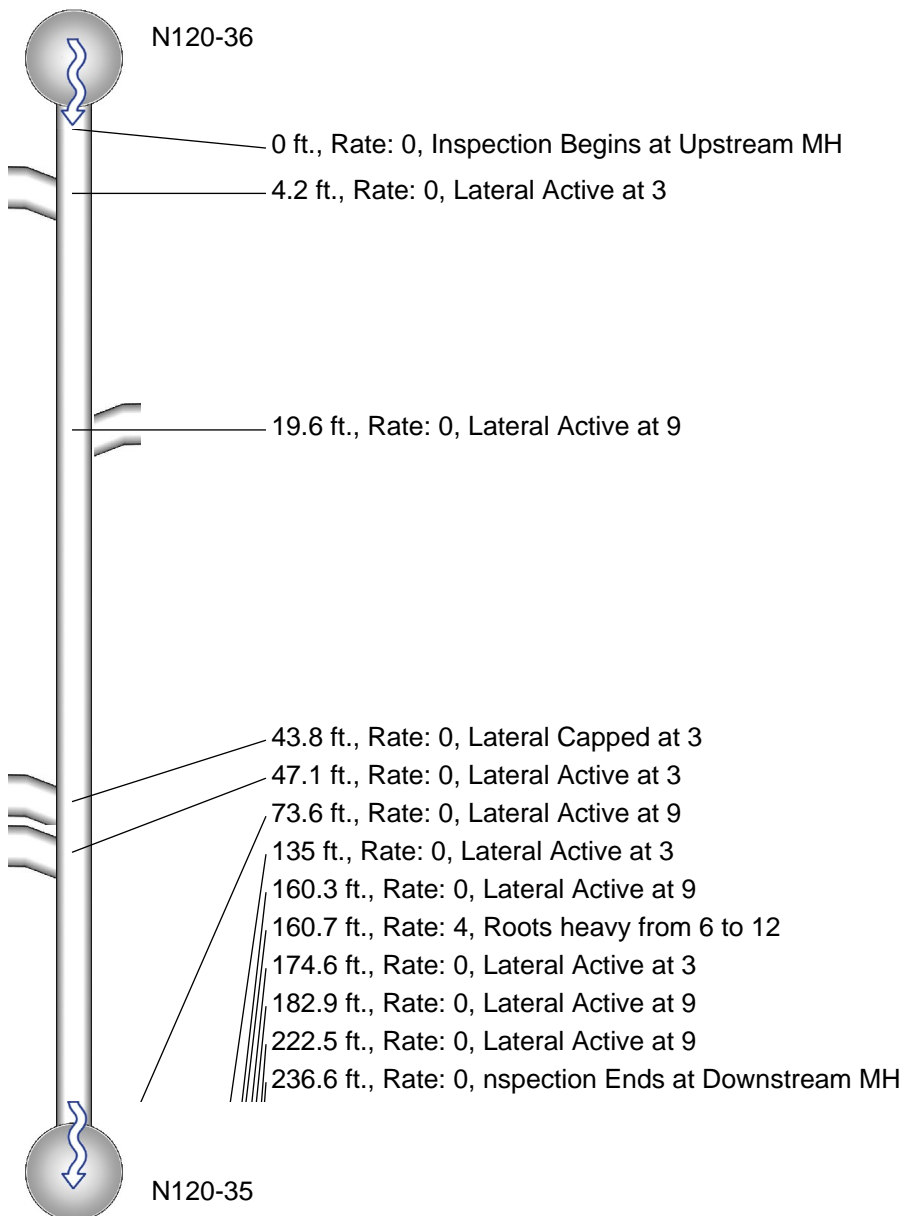
Scaled Plot

Code: CLV	160.3 ft.	9			
Observation: Lateral Active						
Remarks:						
 	Code: MRH	160.7 ft.	6 - 12			
Observation: Roots heavy						
Remarks:						
 	Code: CLV	174.6 ft.	3			
Observation: Lateral Active						
Remarks:						
 	Code: CLV	182.9 ft.	9			
Observation: Lateral Active						
Remarks:						
 	Code: CLV	222.5 ft.	9			
Observation: Lateral Active						
Remarks:						
 	Code: TIED	236.6 ft.				
Observation: nspection Ends at Downstream MH						
Remarks:
