N82-90 TV Observations

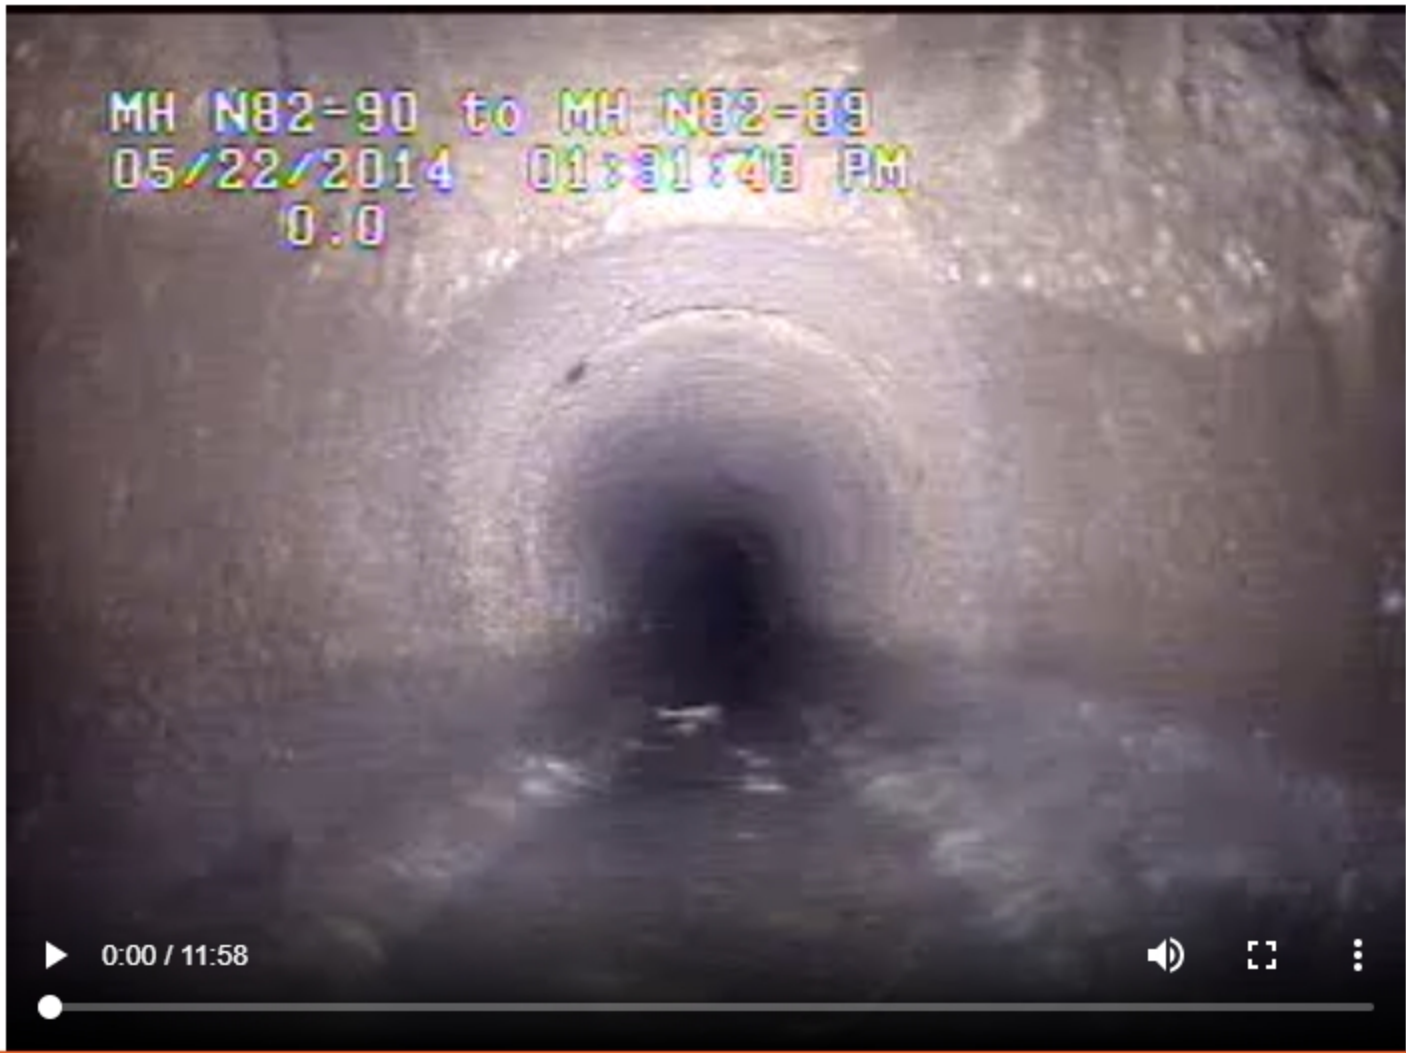
Footage	Digital Time	Clock From	Clock To	Code	Observation	Remarks
0	4			AMH	Manhole	OK
0	7			MWL	Water Level	
10.5	32	3		TF	Tap Factory	
30.2	71	9		TF	Tap Factory	
61.9	176	3	9	FM	Fracture Multiple	
90.4	247	9		TB	Tap Break-in	
98	273	3		TF	Tap Factory	
144.0	362	5	7	DFI	Dist. Fract. Int.

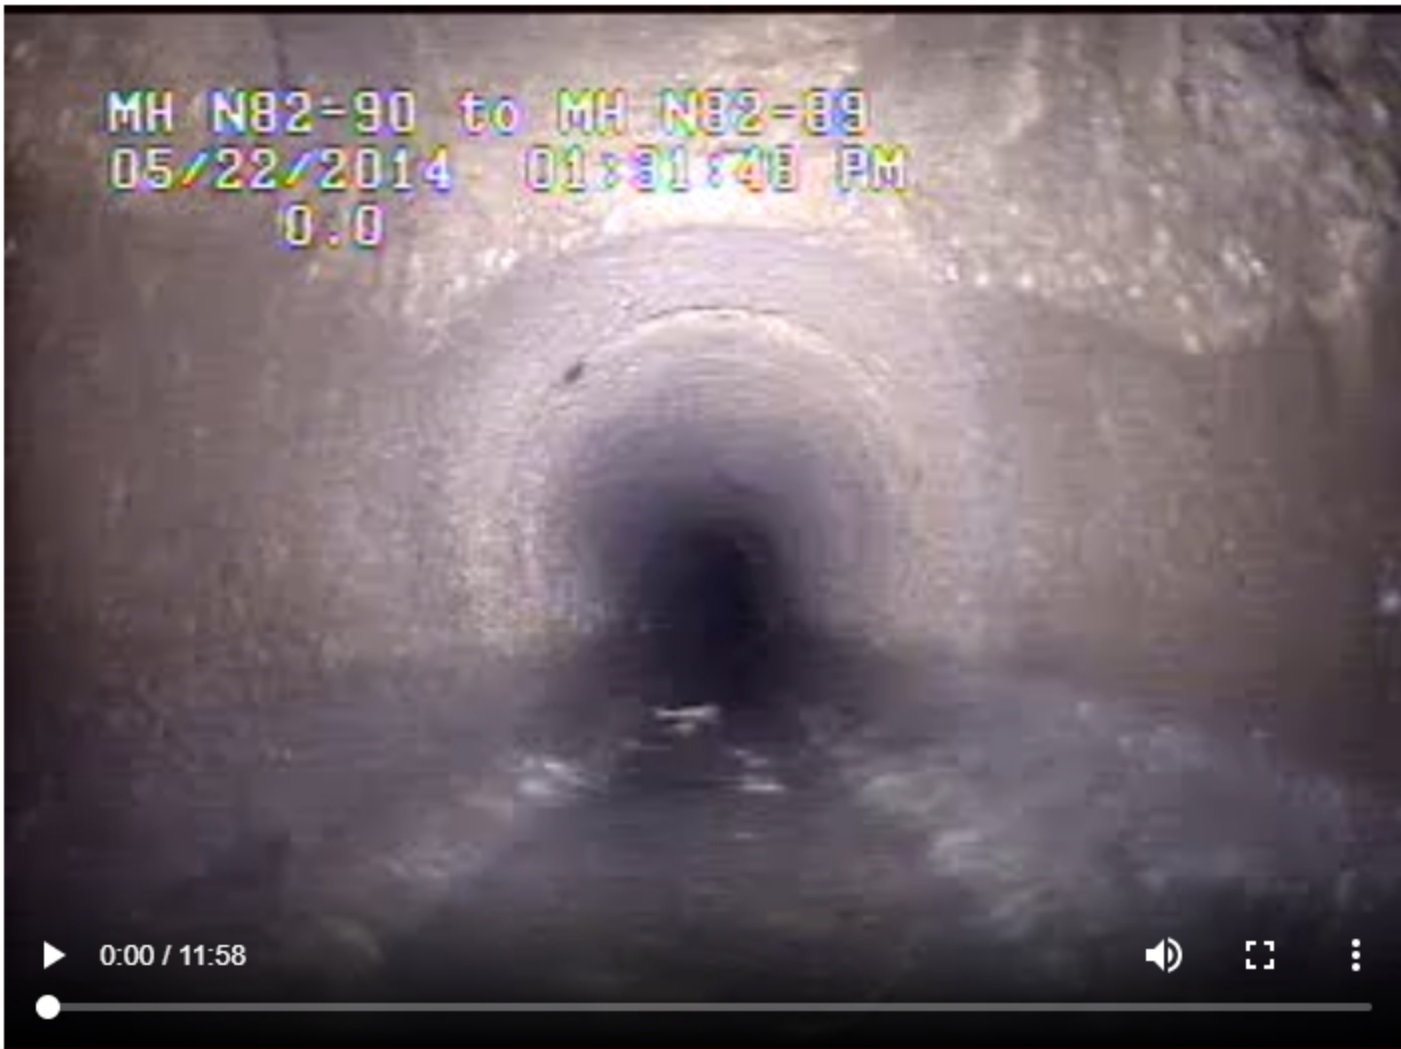
N82-90 TV Observations

90.4	247	9		TB	Tap Break-in	
98	273	3		TF	Tap Factory	
144.9	363	5	7	RFJ	Roots Fine Joint	
173.3	415	9		TF	Tap Factory	
177.3	439	3		TF	Tap Factory	
180.6	455	3	5	RFJ	Roots Fine Joint	
181.4	485	3		TF	Tap Factory	ROOTS IN SERVICE
296	705			AMH	Manhole	ROOT, OLD FRACTURE
