C46-95 TV Observations

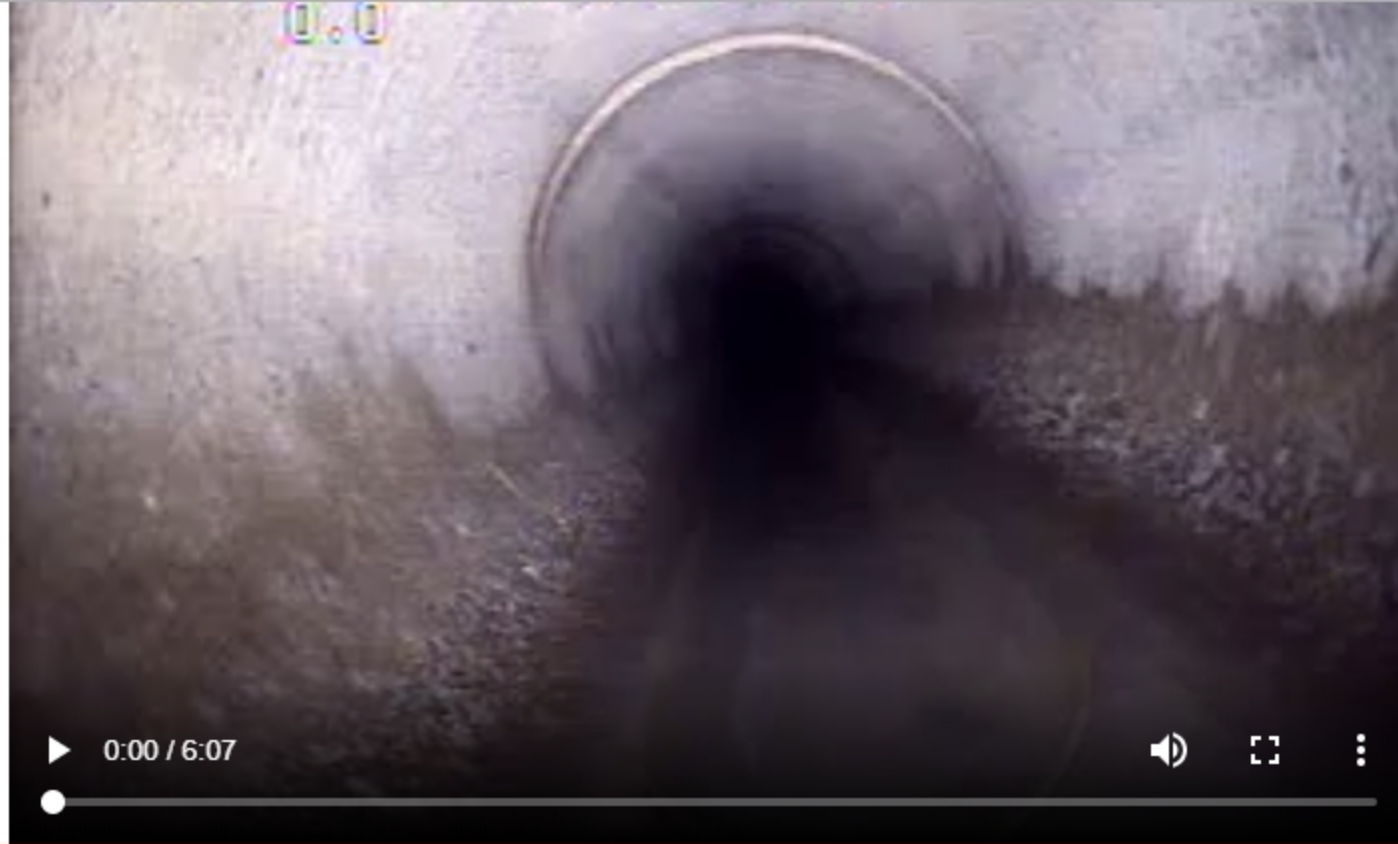
Footage	Digital Time	Clock From	Clock To	Code	Observation	Remarks
0	5			AMH	Manhole	OK
0	7			MWL	Water Level	
9.1	58	3		TB	Tap Break-in	ROOTS FROM SERVICE
99.5	176	7	8	RFJ	Roots Fine Joint	
120.3	208	9		TF	Tap Factory	
136.6	238	3		TF	Tap Factory	
213.1	358			AMH	Manhole	SLIGHT ROOT'S
