### C46-94 TV Observations

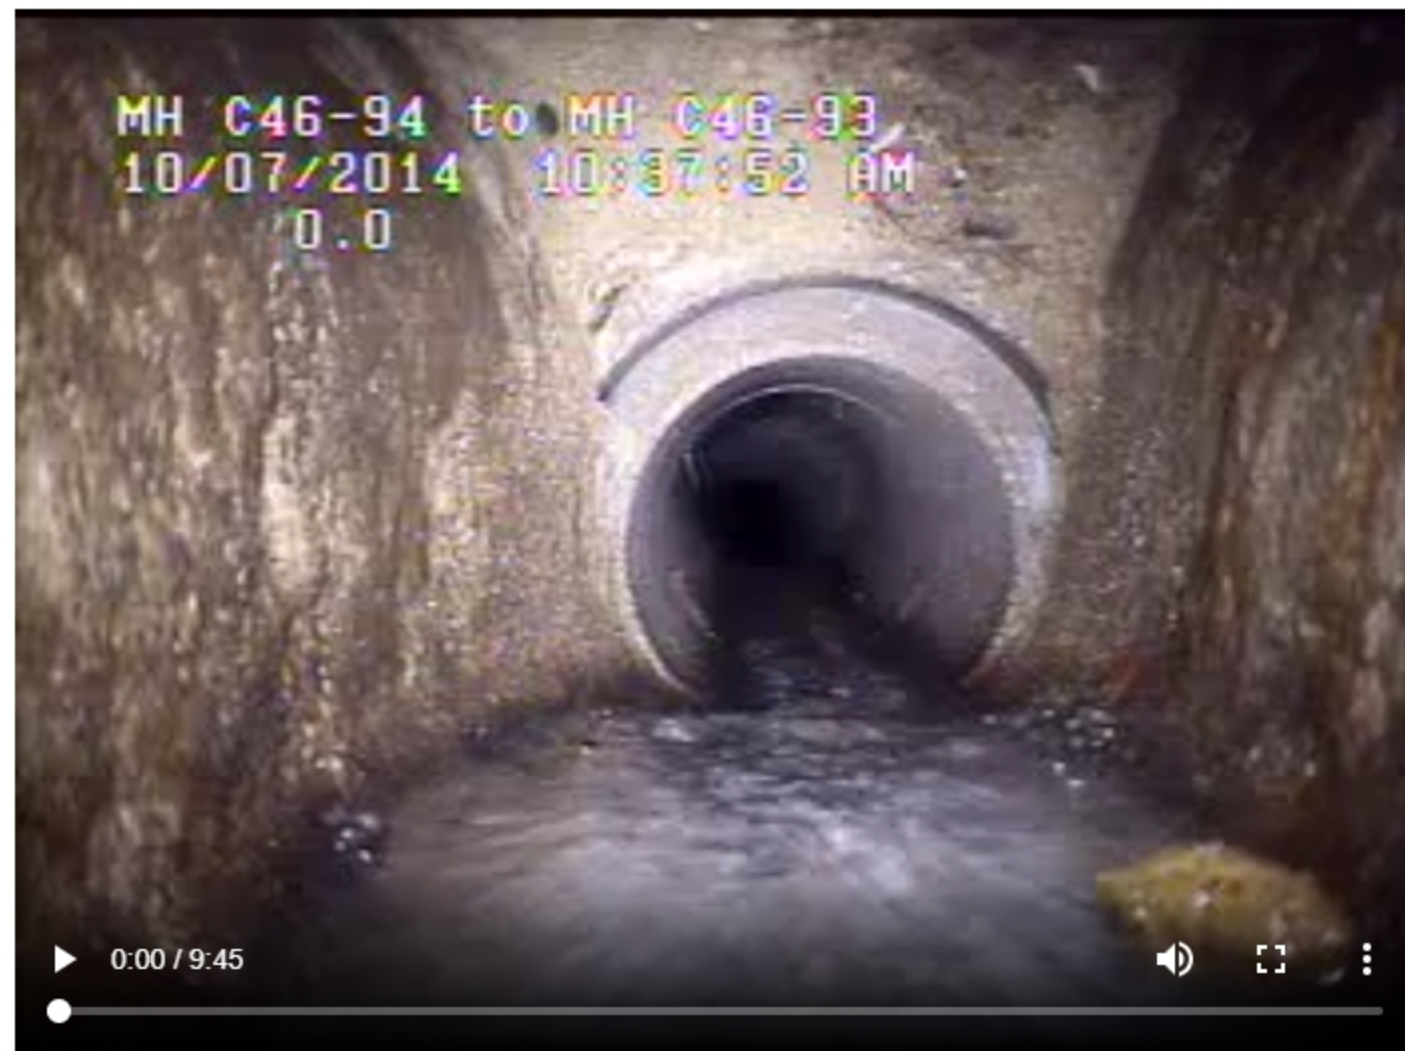
Footage	Digital Time	Clock From	Clock To	Code	Observation	Remarks
0	5			AMH	Manhole	OK
0	8			MWL	Water Level	
14.8	43	3		TF	Tap Factory	
26.8	68	9		TF	Tap Factory	
28.6	78	9		TB	Tap Break-in	
33.1	114	12	12	CC	Crack Circumferential	WITH ROOT'S
95	205	9		TF	Tap Factory	
139	270	7	8	RFI	Roots Fine Joint

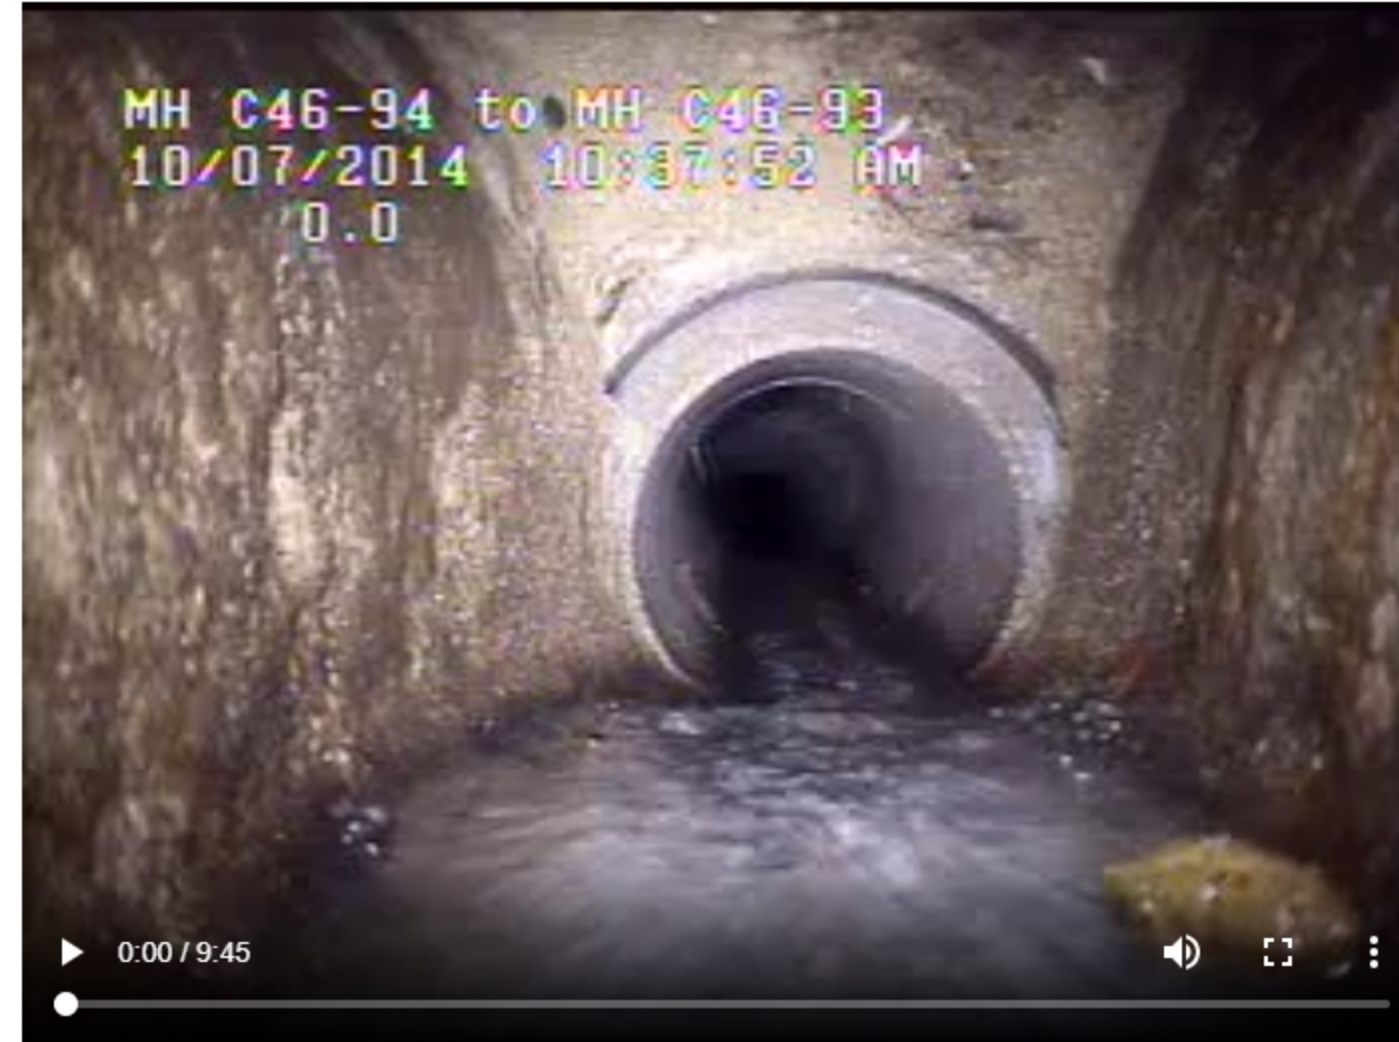
#### C46-94 TV Observations

139	270	7	8	RFJ	Roots Fine Joint	
139.3	279	3		TF	Tap Factory	
140.8	307	3		TB	Tap Break-in	ROOT'S FROM SERVICE
143.3	319	3		TF	Tap Factory	
151.2	342	4	8	RFJ	Roots Fine Joint	
170.6	390	8	4	SAVC	Surface Aggregate Visible Chemical	
198.3	434	3		TB	Tap Break-in	
241.3	573			AMH	Manhole	LITE ROOT'S AND DETERIATION
