Left Plot w/ Pics

Pipe ID L13-3	City	Street CLOVER LN 2200 E	Shape	Map #1	Basin
US Manhole L13-3	Section Length 115.969	Year Laid	Material CON	Section Type	
DS Manhole L13-2	Inspected Length 361.5	Year Renewed	Depth US 10.7	Depth DS	Joint Leng... Diameter 8
Cleaned	Situation		Reason		
Date 20170224	Clean Date	Weather		Remark	
Start Time 14:46					
Operator STEVEN	Customer	Truck 4165	Inspection Dir. DOWNSTREAM	Info	
Operator Comment	P.O. Number	Present	Flow Control	Camera

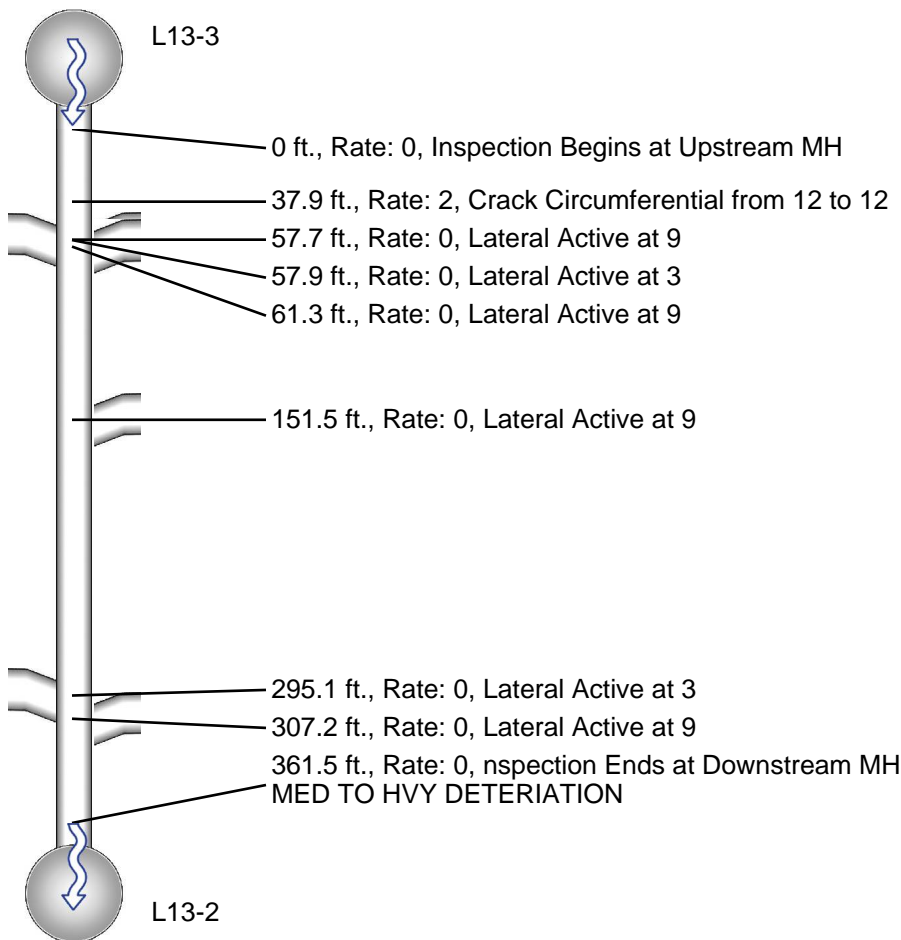
Pipe ID L13-3	City	Street CLOVER LN 2200 E	Shape	Map #1	Basin
US Manhole L13-3	Section Length 115.969	Year Laid	Material CON	Section Type	
DS Manhole L13-2	Inspected Length 361.5	Year Renewed	Depth US 10.7	Depth DS	Joint Leng... Diameter 8

* = clock positions adjusted automatically for reverse inspection

Scale: 1:1200
