Left Plot w/ Pics

Pipe ID N120-44	City	Street VALLEY VIEW AVE 481...	Shape	Map #1	Basin
US Manhole N120-44	Section Length 66.551	Year Laid	Material CON	Section Type	
DS Manhole N120-144	Inspected Length 199.3	Year Renewed	Depth US 8.5	Depth DS	Joint Leng... Diameter 8
Cleaned		Situation		Reason	
Date 20181022	Clean Date	Weather		Remark	
Start Time 10:33					
Operator CODY	Customer	Truck 4161	Inspection Dir. Downstream	Info	
Operator Comment	P.O. Number	Present	Flow Control	Camera

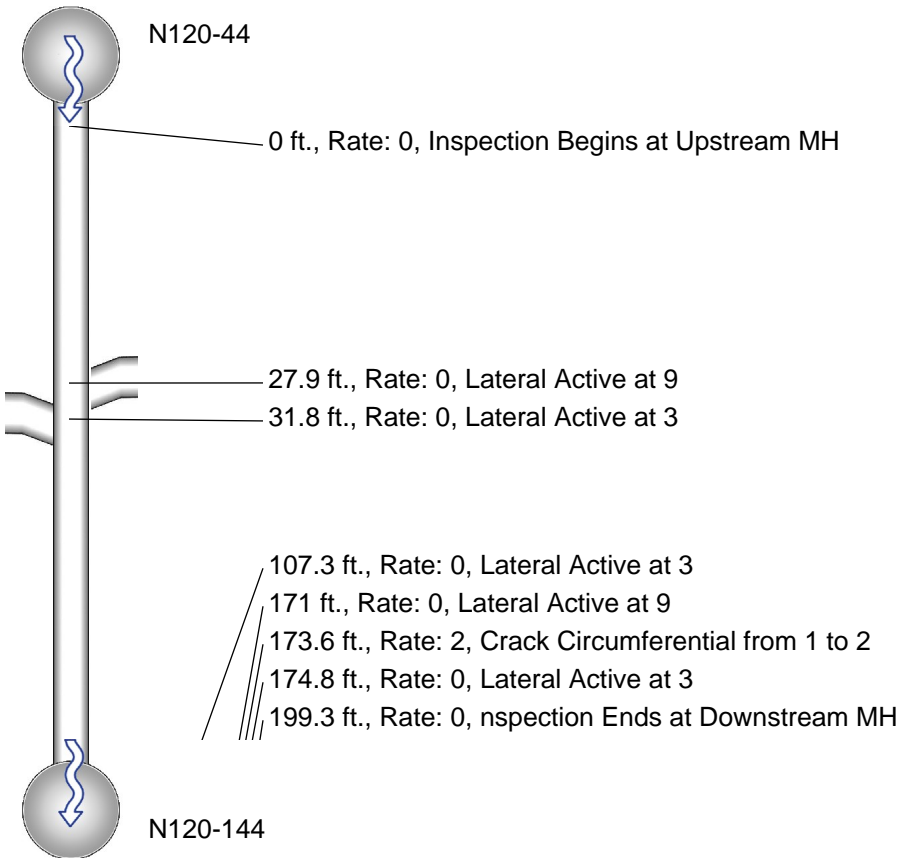
Scaled Plot

Pipe ID N120-44	City	Street VALLEY VIEW AVE 481...	Shape	Map #1	Basin
US Manhole N120-44	Section Length 66.551	Year Laid	Material CON	Section Type	
DS Manhole N120-144	Inspected Length 199.3	Year Renewed	Depth US 8.5	Depth DS	Joint Leng... Diameter 8

* = clock positions adjusted automatically for reverse inspection

Scale: 1:250
