Left Plot w/ Pics

Pipe ID N120-133	City	Street WREN RD 4850 S	Shape	Map #1	Basin
US Manhole N120-133	Section Length 51.55	Year Laid	Material	Section Type	
DS Manhole N120-184	Inspected Length 203.3	Year Renewed	Depth US N/A	Depth DS	Joint Leng... Diameter 8
Cleaned		Situation		Reason	
Date 20181019	Clean Date	Weather		Remark	
Start Time 09:40					
Operator CODY	Customer	Truck 4161	Inspection Dir. Upstream	Info	
Operator Comment	P.O. Number	Present	Flow Control	Camera

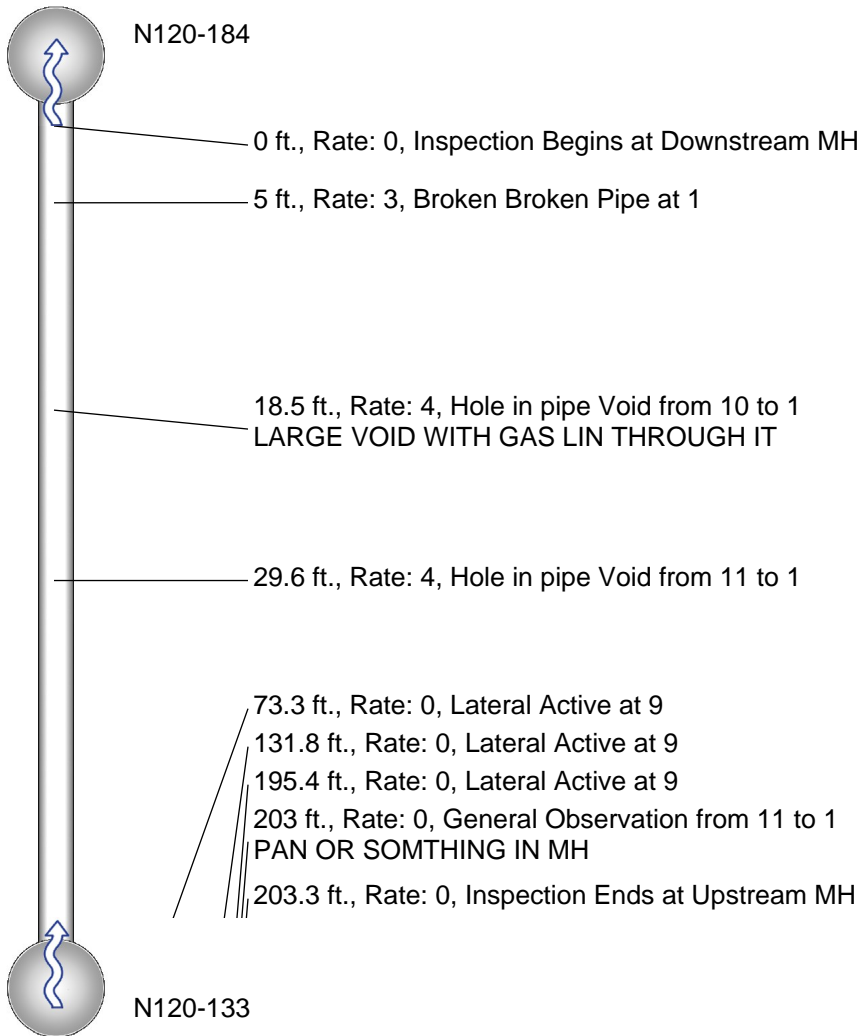
Scaled Plot

Pipe ID N120-133	City	Street WREN RD 4850 S	Shape	Map #1	Basin
US Manhole N120-133	Section Length 51.55	Year Laid	Material	Section Type	
DS Manhole N120-184	Inspected Length 203.3	Year Renewed	Depth US N/A	Depth DS	Joint Leng... Diameter 8

Cleared		Situation		Reason	
Date 20181019	Clean Date	Weather		Remark	
Start Time 09:40					
Operator CODY	Customer	Truck 4161	Inspection Dir. Upstream	Info	
Operator Comment	P.O. Number	Present	Flow Control	Camera

* = clock positions adjusted automatically for reverse inspection

Scale: 1:150

Code: TIBD	0.0 ft.					
Observation: Inspection Begins at Downstream MH							
Remarks:							
 	Code: YBP	5.0 ft.	1				
Observation: Broken Broken Pipe							
Remarks:							
 	Code: YHV	18.5 ft.	10 - 1				
Observation: Hole in pipe Void							
Remarks: LARGE VOID WITH GAS LIN THROUGH IT							
 	Code: YHV	29.6 ft.	11 - 1				
Observation: Hole in pipe Void							
Remarks:							
 	Code: CLV	73.3 ft.	9				
Observation: Lateral Active							
Remarks:							
 	Code: CLV	131.8 ft.	9				
Observation: Lateral Active							
Remarks:							
 	Code: CLV	195.4 ft.	9				
Observation: Lateral Active							
Remarks:

Code: TGO 203.0 ft. 11 - 1

Observation: General Observation
Remarks: PAN OR SOMTHING IN MH
