Left Plot w/ Pics

Pipe ID N120-18	City	Street BON AIR ST 4885 S	Shape	Map #1	Basin
US Manhole N120-18	Section Length 76.374	Year Laid	Material CON	Section Type	
DS Manhole N120-17	Inspected Length 229.7	Year Renewed	Depth US 5	Depth DS	Joint Leng... Diameter 8
Cleaned		Situation		Reason	
Date 20181102	Clean Date	Weather		Remark	
Start Time 12:13					
Operator CODY	Customer	Truck 4161	Inspection Dir. Downstream	Info	
Operator Comment	P.O. Number	Present	Flow Control	Camera

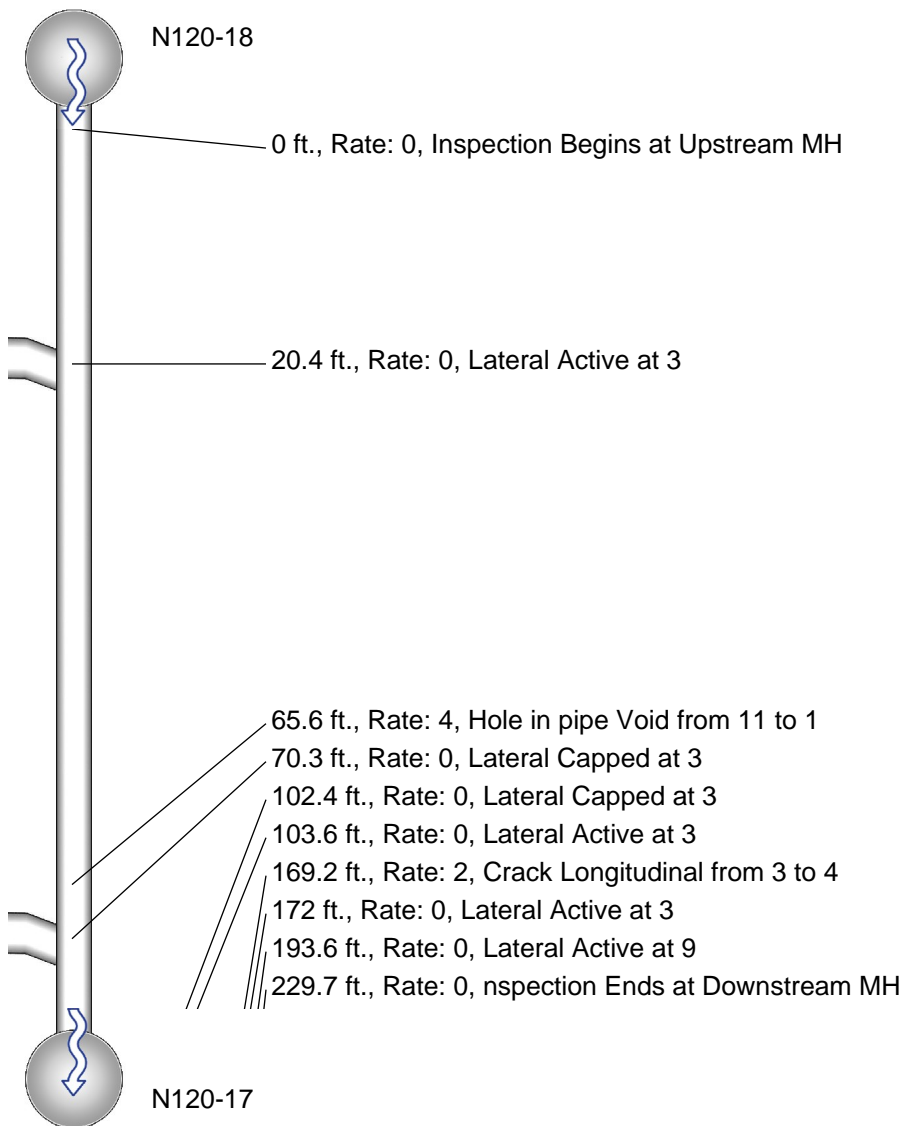
Pipe ID N120-18	City	Street BON AIR ST 4885 S	Shape	Map #1	Basin
US Manhole N120-18	Section Length 76.374	Year Laid	Material CON	Section Type	
DS Manhole N120-17	Inspected Length 229.7	Year Renewed	Depth US 5	Depth DS	Joint Leng... Diameter 8

Cleared		Situation		Reason	
Date 20181102	Clean Date	Weather		Remark	
Start Time 12:13					
Operator CODY	Customer	Truck 4161	Inspection Dir. Downstream	Info	
Operator Comment	P.O. Number	Present	Flow Control	Camera

* = clock positions adjusted automatically for reverse inspection

Scale: 1:200

Code: TIBU	0.0 ft.					
Observation: Inspection Begins at Upstream MH							
Remarks:

Code: CLV	20.4 ft.	3				
Observation: Lateral Active							
Remarks:

Code: YHV	65.6 ft.	11 - 1				
Observation: Hole in pipe Void							
Remarks:

Code: CLC	70.3 ft.	3				
Observation: Lateral Capped							
Remarks:

Code: CLC	102.4 ft.	3				
Observation: Lateral Capped							
Remarks:

Code: CLV	103.6 ft.	3				
Observation: Lateral Active							
Remarks:

Code: YCL	169.2 ft.	3 - 4				
Observation: Crack Longitudinal							
Remarks:

Code: CLV 172.0 ft. 3

Observation: Lateral Active
