Pipe ID L8-10	City	Street LINCOLN CIR 4155 S	Shape	Map #1	Basin
US Manhole L8-10	Section Length 91.669	Year Laid	Material PRC	Section Type	
DS Manhole L8-2	Inspected Length 116	Year Renewed	Depth US 10.5	Depth DS	Joint Leng... Diameter 8
Cleaned	Situation		Reason		
Date 20160426	Clean Date	Weather		Remark	
Start Time 14:06					
Operator MIKE	Customer	Truck 4165	Inspection Dir. DOWNSTREAM	Info	
Operator Comment	P.O. Number	Present	Flow Control	Camera

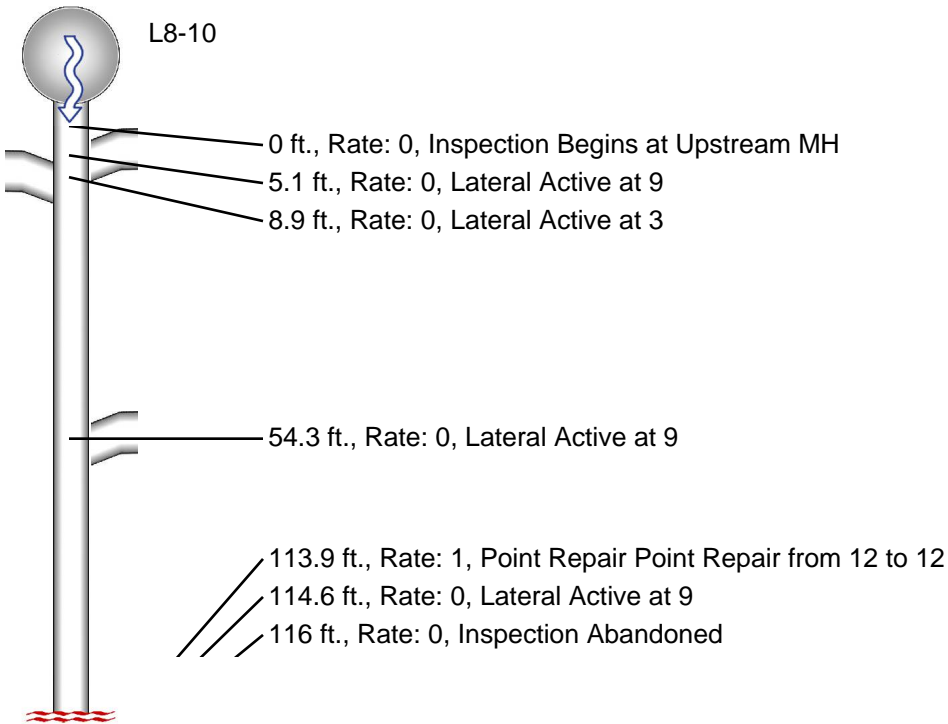
Scaled Plot

Pipe ID L8-10	City	Street LINCOLN CIR 4155 S	Shape	Map #1	Basin
US Manhole L8-10	Section Length 91.669	Year Laid	Material PRC	Section Type	
DS Manhole L8-2	Inspected Length 116	Year Renewed	Depth US 10.5	Depth DS	Joint Leng... Diameter 8

* = clock positions adjusted automatically for reverse inspection

Scale: 1:400
