### Left Plot w/ Pics

Pipe ID <b>L8-3</b>	City	Street <b>LYNNE LN 2000 E</b>	Shape	Map #1	Basin
<b>US Manhole</b> <b>L8-3</b>	Section Length <b>77.127</b>	Year Laid	Material <b>PRC</b>	Section Type	
<b>DS Manhole</b> <b>L8-2</b>	Inspected Length <b>262.9</b>	Year Renewed	Depth US <b>10</b>	Depth DS	Joint Leng... Diameter <b>8</b>
Cleaned	Situation		Reason		
Date <b>20160503</b>	Clean Date	Weather		Remark	
Start Time <b>10:54</b>					
Operator <b>MIKE</b>	Customer	Truck <b>4165</b>	Inspection Dir. <b>DOWNSTREAM</b>	Info	
Operator Comment	P.O. Number	Present	Flow Control	Camera

### Scaled Plot

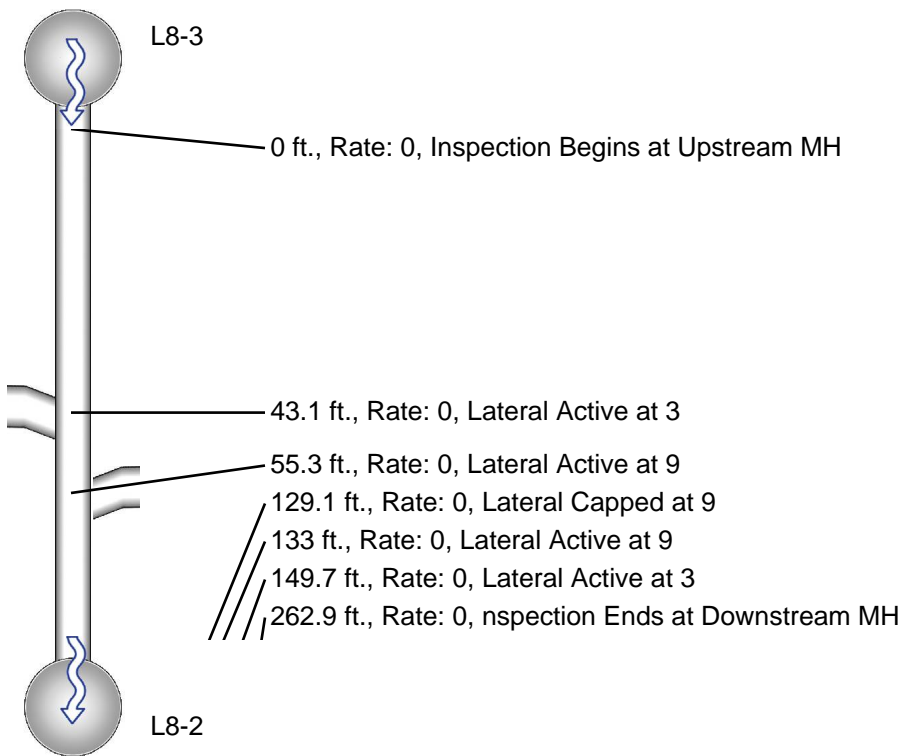
Pipe ID <b>L8-3</b>	City	Street <b>LYNNE LN 2000 E</b>	Shape	Map #1	Basin
<b>US Manhole</b> <b>L8-3</b>	Section Length <b>77.127</b>	Year Laid	Material <b>PRC</b>	Section Type	
<b>DS Manhole</b> <b>L8-2</b>	Inspected Length <b>262.9</b>	Year Renewed	Depth US <b>10</b>	Depth DS	Joint Leng... Diameter <b>8</b>

Scale: 1:350

Code: TIBU	0.0 ft.						
Observation: Inspection Begins at Upstream MH								
Remarks:								
	Code: CLV	43.1 ft.	3					
Observation: Lateral Active								
Remarks:								
	Code: CLV	55.3 ft.	9					
Observation: Lateral Active								
Remarks:								
	Code: CLC	129.1 ft.	9					
Observation: Lateral Capped								
Remarks:								
	Code: CLV	133.0 ft.	9					
Observation: Lateral Active								
Remarks:								
	Code: CLV	149.7 ft.	3					
Observation: Lateral Active								
Remarks:								
	Code: TIED	262.9 ft.						
Observation: nspection Ends at Downstream MH								
Remarks:
