Left Plot w/ Pics

Pipe ID L8-2	City	Street LYNNE LN 2000 E	Shape	Map #1	Basin
US Manhole L8-2	Section Length 77.535	Year Laid	Material CON	Section Type	
DS Manhole L8-1	Inspected Length 202	Year Renewed	Depth US 9	Depth DS	Joint Leng... Diameter 8
Cleaned	Situation		Reason		
Date 20170908	Clean Date	Weather		Remark	
Start Time 14:01					
Operator STEVEN	Customer	Truck 4165	Inspection Dir. DOWNSTREAM	Info	
Operator Comment	P.O. Number	Present	Flow Control	Camera

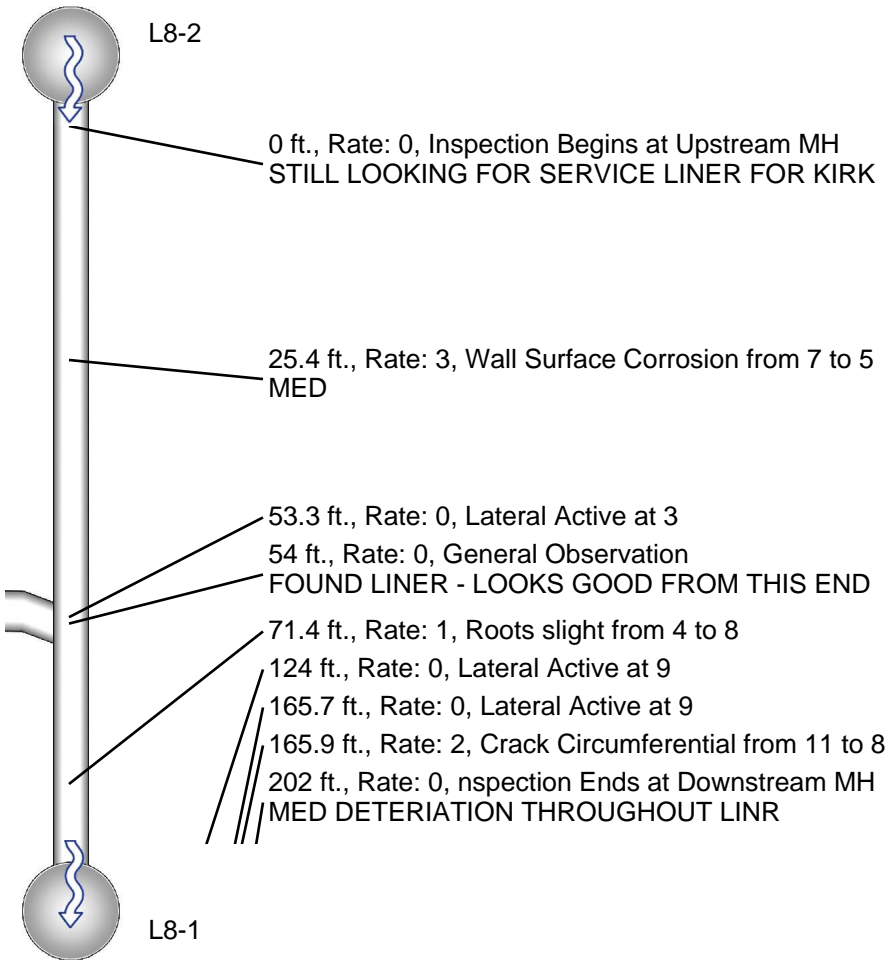
Pipe ID L8-2	City	Street LYNNE LN 2000 E	Shape	Map #1	Basin
US Manhole L8-2	Section Length 77.535	Year Laid	Material CON	Section Type	
DS Manhole L8-1	Inspected Length 202	Year Renewed	Depth US 9	Depth DS	Joint Leng... Diameter 8

* = clock positions adjusted automatically for reverse inspection

Scale: 1:250

Code: TIBU	0.0 ft.					
Observation: Inspection Begins at Upstream MH							
Remarks: STILL LOOKING FOR SERVICE LINER FOR KIRK

Code: YWC	25.4 ft.	7 - 5				
Observation: Wall Surface Corrosion							
Remarks: MED

Code: CLV	53.3 ft.	3				
Observation: Lateral Active							
Remarks:

Code: TGO	54.0 ft.					
Observation: General Observation							
Remarks: FOUND LINER - LOOKS GOOD FROM THIS END

Code: MRS	71.4 ft.	4 - 8				
Observation: Roots slight							
Remarks:

Code: CLV	124.0 ft.	9				
Observation: Lateral Active							
Remarks:

Code: CLV	165.7 ft.	9				
Observation: Lateral Active							
Remarks:

Code: YCC	165.9 ft.	11 - 8			
Observation: Crack Circumferential					
Remarks:
