Pipe ID N120-97	City	Street BRANCH DR 4745 S	Shape	Map #1	Basin
US Manhole N120-97	Section Length 61.885	Year Laid	Material PRC	Section Type	
DS Manhole N120-96	Inspected Length 166.9	Year Renewed	Depth US 8.8	Depth DS	Joint Leng... Diameter 8
Cleaned		Situation		Reason	
Date 20181030	Clean Date	Weather		Remark	
Start Time 13:28					
Operator CODY	Customer	Truck 4161	Inspection Dir. Downstream	Info	
Operator Comment	P.O. Number	Present	Flow Control	Camera

Scaled Plot

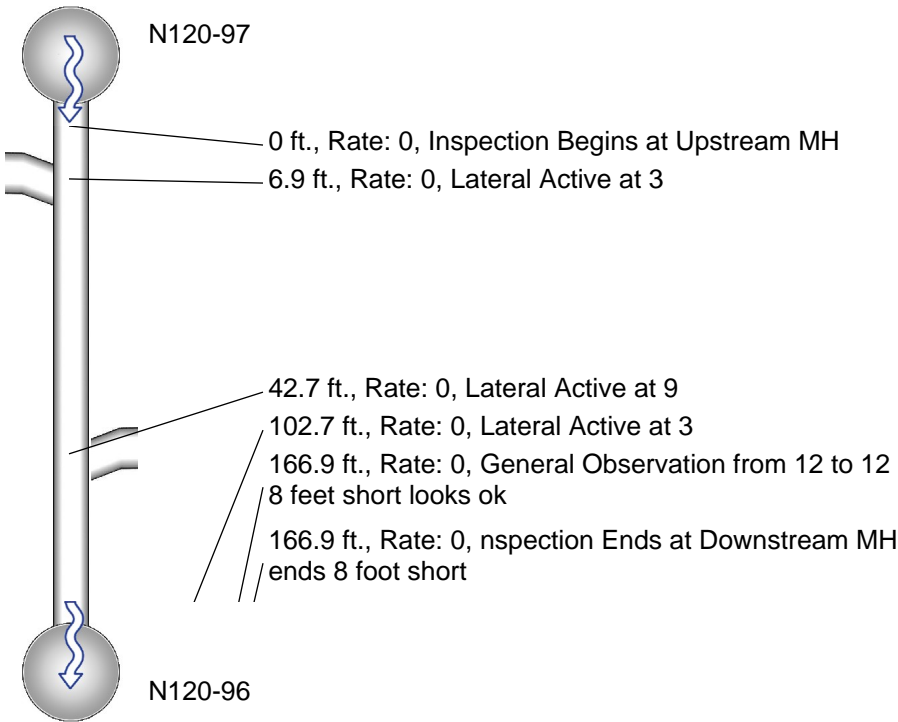
Pipe ID N120-97	City	Street BRANCH DR 4745 S	Shape	Map #1	Basin
US Manhole N120-97	Section Length 61.885	Year Laid	Material PRC	Section Type	
DS Manhole N120-96	Inspected Length 166.9	Year Renewed	Depth US 8.8	Depth DS	Joint Leng... Diameter 8

* = clock positions adjusted automatically for reverse inspection

Scale: 1:300
