Left Plot w/ Pics

Pipe ID N143-22	City	Street 2720 E	Shape	Map #1	Basin
US Manhole N143-22	Section Length 90.435	Year Laid	Material CON	Section Type	
DS Manhole N143-9	Inspected Length 342.8	Year Renewed	Depth US 8	Depth DS	Joint Leng... Diameter 8
Cleaned	Situation		Reason		
Date 20181109	Clean Date	Weather		Remark	
Start Time 14:30					
Operator STEVEN	Customer	Truck 4165	Inspection Dir. DOWNSTREAM	Info	
Operator Comment	P.O. Number	Present	Flow Control	Camera

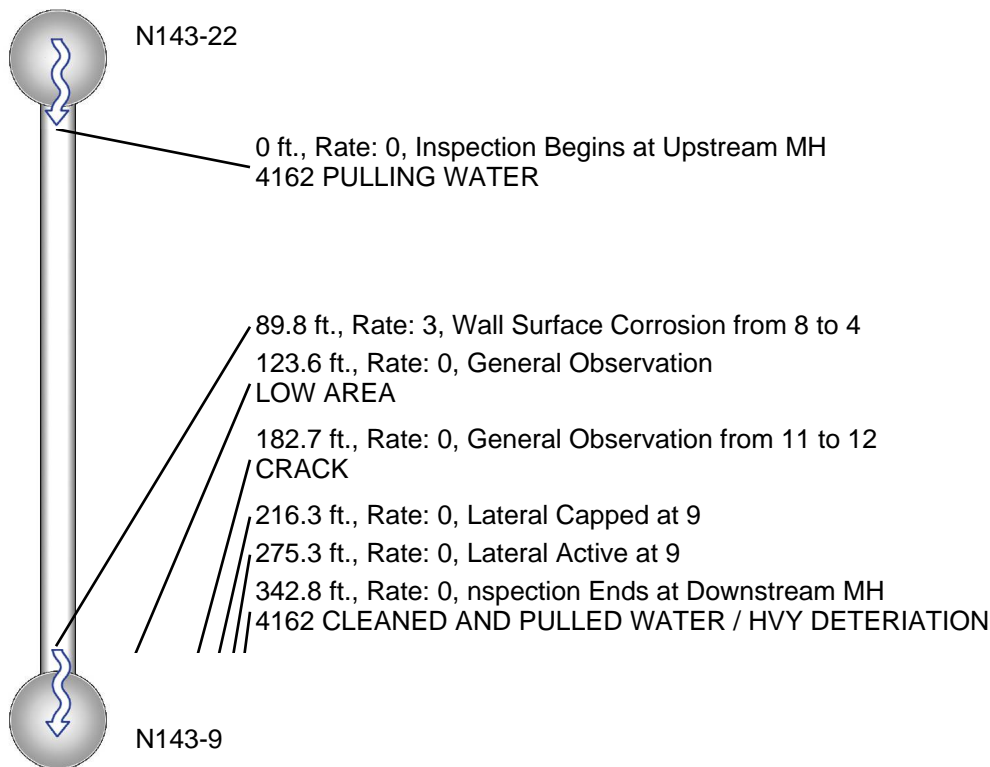
Scaled Plot

Pipe ID N143-22	City	Street 2720 E	Shape	Map #1	Basin
US Manhole N143-22	Section Length 90.435	Year Laid	Material CON	Section Type	
DS Manhole N143-9	Inspected Length 342.8	Year Renewed	Depth US 8	Depth DS	Joint Leng... Diameter 8

* = clock positions adjusted automatically for reverse inspection

Scale: 1:400
