Left Plot w/ Pics

Pipe ID N143-10	City	Street HOLLADAY BLVD 2750 ...	Shape	Map #1	Basin
US Manhole N143-10	Section Length 79.746	Year Laid	Material CON	Section Type	
DS Manhole N143-9	Inspected Length 259.2	Year Renewed	Depth US 11	Depth DS	Joint Leng... Diameter 8
Cleaned	Situation		Reason		
Date 20181113	Clean Date	Weather		Remark	
Start Time 13:32					
Operator KEVINT	Customer	Truck 4165	Inspection Dir. UPSTREAM	Info	
Operator Comment	P.O. Number	Present	Flow Control	Camera

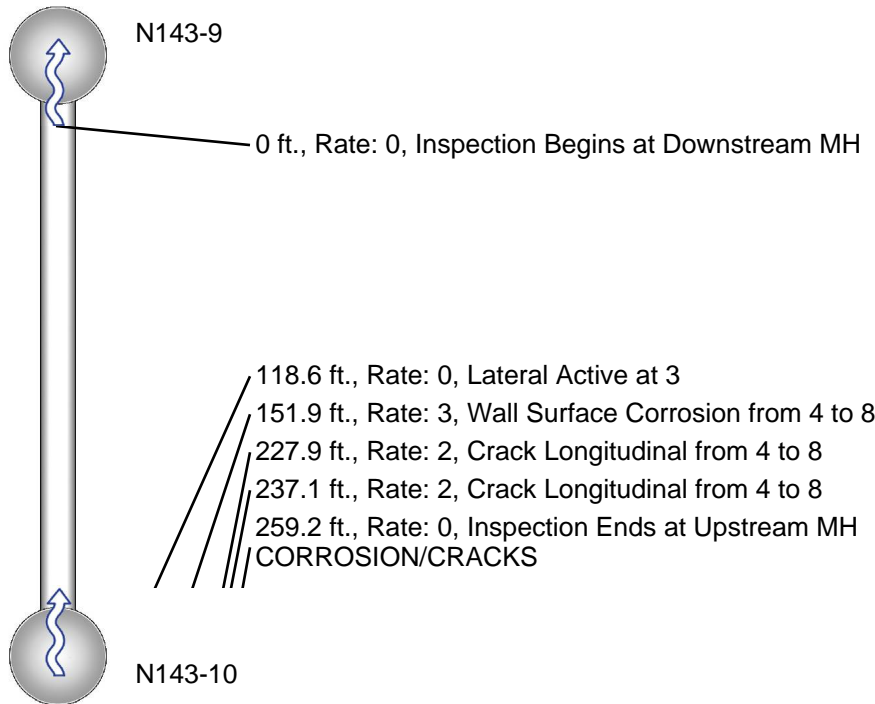
Scaled Plot

Pipe ID N143-10	City	Street HOLLADAY BLVD 2750 ...	Shape	Map #1	Basin
US Manhole N143-10	Section Length 79.746	Year Laid	Material CON	Section Type	
DS Manhole N143-9	Inspected Length 259.2	Year Renewed	Depth US 11	Depth DS	Joint Leng... Diameter 8

* = clock positions adjusted automatically for reverse inspection

Scale: 1:400

Code: CLV	118.6 ft.	3			
Observation: Lateral Active					
Remarks:

Code: YWC	151.9 ft.	4 - 8			
Observation: Wall Surface Corrosion					
Remarks:

Code: YCL	227.9 ft.	4 - 8			
Observation: Crack Longitudinal					
Remarks:

Code: YCL	237.1 ft.	4 - 8			
Observation: Crack Longitudinal					
Remarks:

Code: TIEU	259.2 ft.				
Observation: Inspection Ends at Upstream MH					
Remarks: CORROSION/CRACKS
