### Left Plot w/ Pics

| Pipe ID<br><b>L12-2</b> | City | Street<br><b>CUMBERLAND RD 2145 ...</b> | Shape | Map #1 | Basin |
| <b>US Manhole</b><br><b>L12-2</b> | Section Length<br><b>80.698</b> | Year Laid | Material<br><b>CON</b> | Section Type | |
| <b>DS Manhole</b><br><b>L12-1</b> | Inspected Length<br><b>214.9</b> | Year Renewed | Depth US<br><b>12</b> | Depth DS | Joint Leng...<br>Diameter<br><b>10</b> |

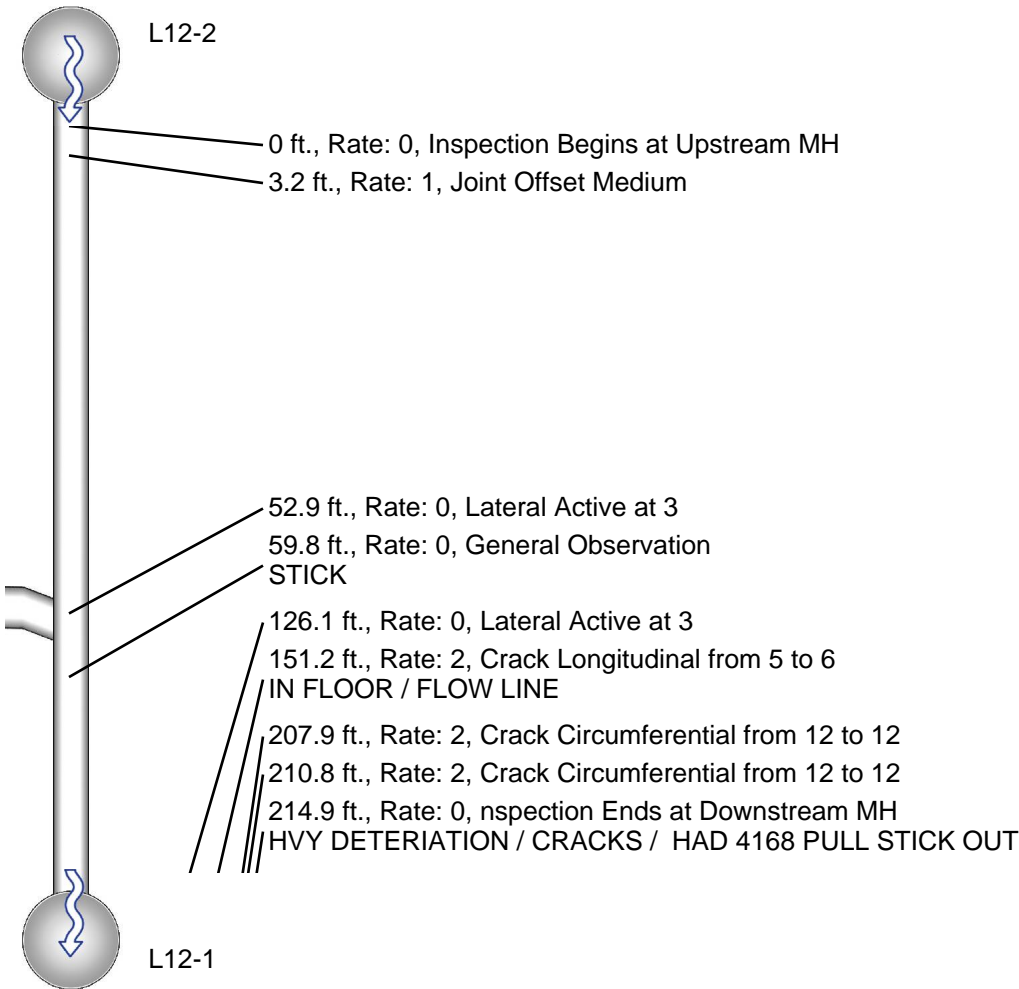
\* = clock positions adjusted automatically for reverse inspection

Scale: 1:250
