Left Plot w/ Pics

Pipe ID L12-3	City	Street CUMBERLAND RD 2145 ...	Shape	Map #1	Basin
US Manhole L12-3	Section Length 65.804	Year Laid	Material CON	Section Type	
DS Manhole L12-2	Inspected Length 251.7	Year Renewed	Depth US 13	Depth DS	Joint Leng... Diameter 8
Cleaned	Situation		Reason		
Date 20170302	Clean Date	Weather		Remark	
Start Time 13:18					
Operator STEVEN	Customer	Truck 4165	Inspection Dir. DOWNSTREAM	Info	
Operator Comment	P.O. Number	Present	Flow Control	Camera

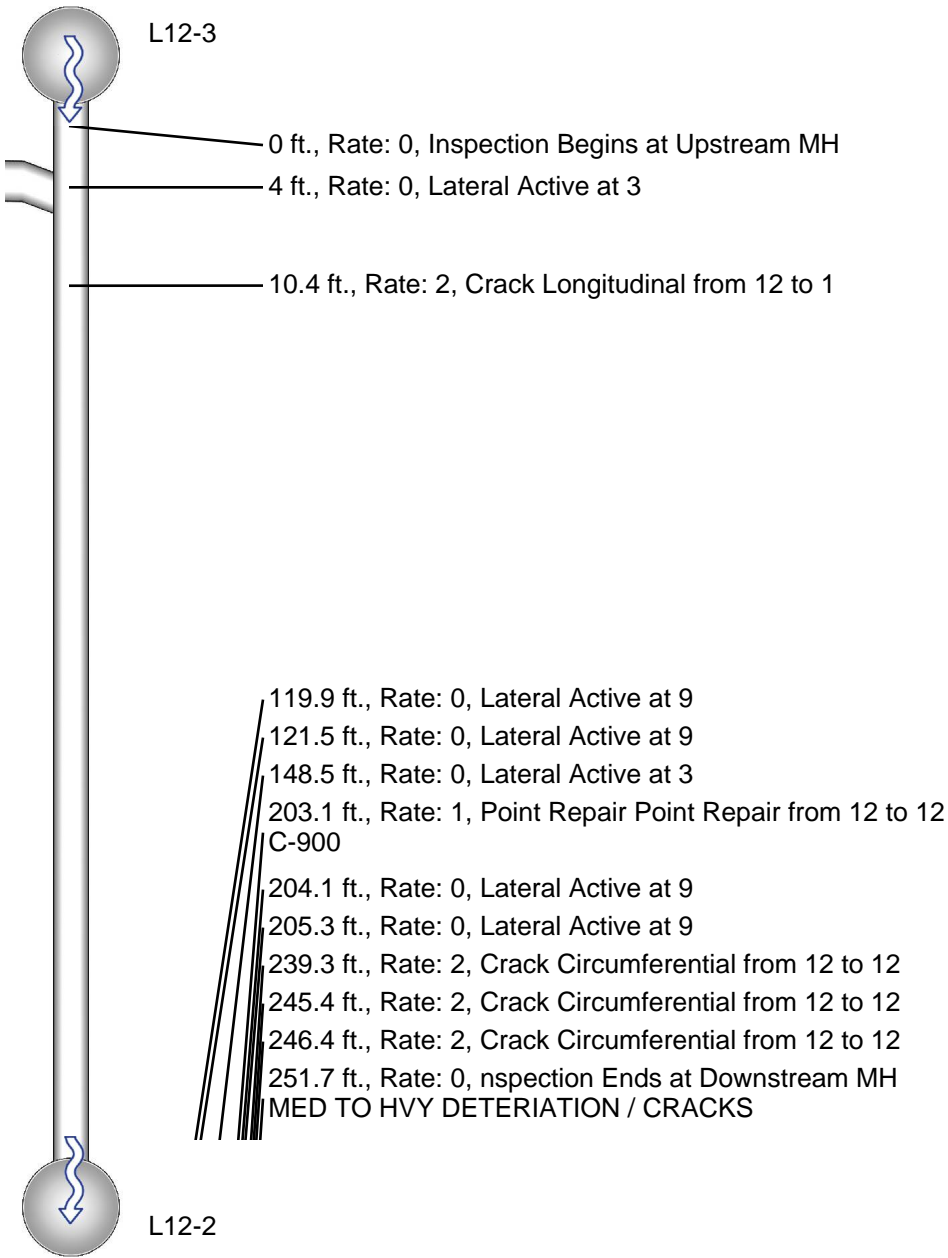
Pipe ID L12-3	City	Street CUMBERLAND RD 2145 ...	Shape	Map #1	Basin
US Manhole L12-3	Section Length 65.804	Year Laid	Material CON	Section Type	
DS Manhole L12-2	Inspected Length 251.7	Year Renewed	Depth US 13	Depth DS	Joint Leng... Diameter 8

Cleared		Situation		Reason	
Date 20170302	Clean Date	Weather		Remark	
Start Time 13:18					
Operator STEVEN	Customer	Truck 4165	Inspection Dir. DOWNSTREAM	Info	
Operator Comment	P.O. Number	Present	Flow Control	Camera

* = clock positions adjusted automatically for reverse inspection

Scale: 1:150

Code: TIBU	0.0 ft.				
Observation: Inspection Begins at Upstream MH					
Remarks:

Code: CLV	4.0 ft.	3			
Observation: Lateral Active					
Remarks:

Code: YCL	10.4 ft.	12 - 1			
Observation: Crack Longitudinal					
Remarks:

Code: CLV	119.9 ft.	9			
Observation: Lateral Active					
Remarks:

Code: CLV	121.5 ft.	9			
Observation: Lateral Active					
Remarks:

Code: CLV	148.5 ft.	3			
Observation: Lateral Active					
Remarks:

Code: TPR	203.1 ft.	12 - 12			
Observation: Point Repair Point Repair					
Remarks: C-900

Code: CLV	204.1 ft.	9			
Observation: Lateral Active					
Remarks:

Code: CLV	205.3 ft.	9			
Observation: Lateral Active					
Remarks:

Code: YCC	239.3 ft.	12 - 12			
Observation: Crack Circumferential					
Remarks:

Code: YCC	245.4 ft.	12 - 12			
Observation: Crack Circumferential					
Remarks:

Code: YCC	246.4 ft.	12 - 12			
Observation: Crack Circumferential					
Remarks:

Code: TIED	251.7 ft.				
Observation: nspection Ends at Downstream MH					
Remarks: MED TO HVY DETERIATION / CRACKS
