Left Plot w/ Pics

Pipe ID N120-96	City	Street NANILOA DR 2870 E	Shape	Map #1	Basin
US Manhole N120-96	Section Length 38.14	Year Laid	Material PRC	Section Type	
DS Manhole N120-90	Inspected Length 83.3	Year Renewed	Depth US 10	Depth DS	Joint Leng... Diameter 8
Cleaned	Situation		Reason		
Date 20170816	Clean Date	Weather		Remark	
Start Time 08:48					
Operator STEVEN	Customer	Truck 4165	Inspection Dir. DOWNSTREAM	Info	
Operator Comment	P.O. Number	Present	Flow Control	Camera

Scaled Plot

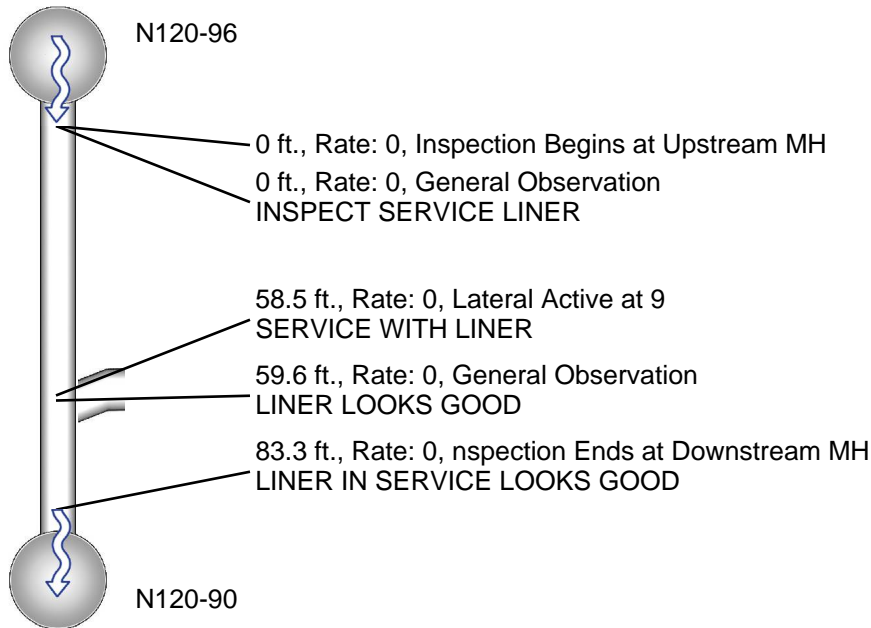
Pipe ID N120-96	City	Street NANILOA DR 2870 E	Shape	Map #1	Basin
US Manhole N120-96	Section Length 38.14	Year Laid	Material PRC	Section Type	
DS Manhole N120-90	Inspected Length 83.3	Year Renewed	Depth US 10	Depth DS	Joint Leng... Diameter 8

* = clock positions adjusted automatically for reverse inspection

Scale: 1:500

Code: CLV	58.5 ft.	9			
Observation: Lateral Active					
Remarks: SERVICE WITH LINER

Code: TGO	59.6 ft.				
Observation: General Observation					
Remarks: LINER LOOKS GOOD

Code: TIED	83.3 ft.				
Observation: Inspection Ends at Downstream MH					
Remarks: LINER IN SERVICE LOOKS GOOD
