Left Plot w/ Pics

Pipe ID D49-69	City	Street STRATTON DR 3075 E	Shape	Map #1	Basin
US Manhole D49-69	Section Length 45.014	Year Laid	Material PRC	Section Type	
DS Manhole D49-68	Inspected Length 177.3	Year Renewed	Depth US 8.9	Depth DS	Joint Leng... Diameter 12
Cleaned	Situation		Reason		
Date 20181226	Clean Date	Weather		Remark	
Start Time 13:27					
Operator KEVINT	Customer	Truck 4165	Inspection Dir. DOWNSTREAM	Info	
Operator Comment	P.O. Number	Present	Flow Control	Camera

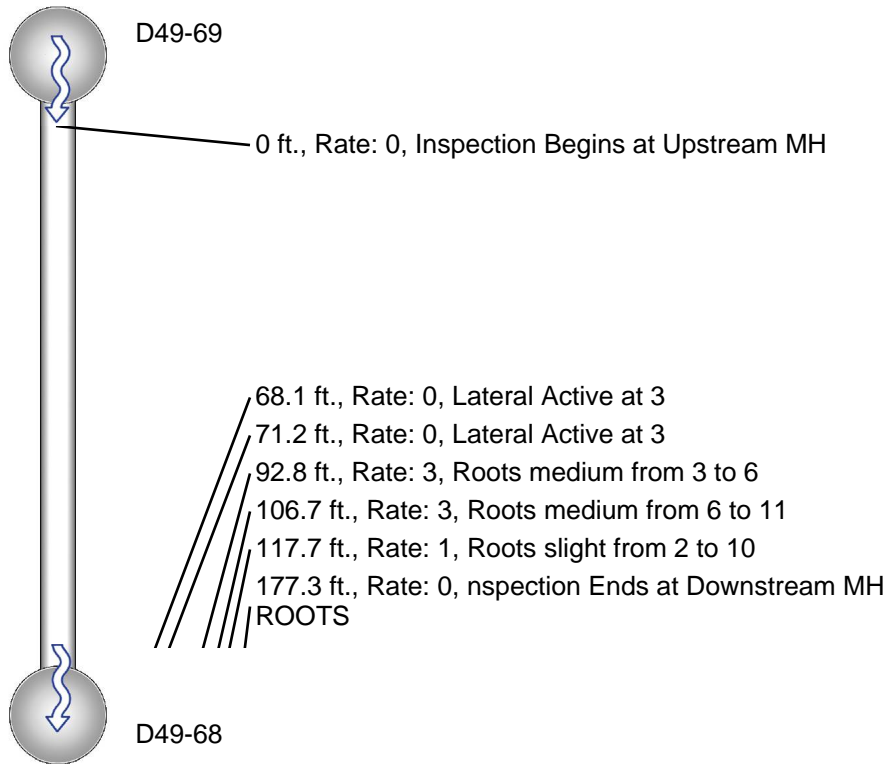
Scaled Plot

Pipe ID D49-69	City	Street STRATTON DR 3075 E	Shape	Map #1	Basin
US Manhole D49-69	Section Length 45.014	Year Laid	Material PRC	Section Type	
DS Manhole D49-68	Inspected Length 177.3	Year Renewed	Depth US 8.9	Depth DS	Joint Leng... Diameter 12

Cleared		Situation		Reason	
Date 20181226	Clean Date	Weather		Remark	
Start Time 13:27					
Operator KEVINT	Customer	Truck 4165	Inspection Dir. DOWNSTREAM	Info	
Operator Comment	P.O. Number	Present	Flow Control	Camera

* = clock positions adjusted automatically for reverse inspection

Scale: 1:200
