### Left Plot w/ Pics

Pipe ID <b>I98</b>	City	Street <b>1300 E</b>	Shape	Map #1	Basin
<b>US Manhole</b> <b>I98</b>	Section Length <b>118.763</b>	Year Laid	Material <b>CON</b>	Section Type	
<b>DS Manhole</b> <b>I97</b>	Inspected Length <b>402.8</b>	Year Renewed	Depth US <b>14</b>	Depth DS	Joint Leng... Diameter <b>18</b>
Cleaned		Situation		Reason	
Date <b>20181207</b>	Clean Date	Weather		Remark	
Start Time <b>13:24</b>					
Operator <b>CODY</b>	Customer	Truck <b>4161</b>	Inspection Dir. <b>Downstream</b>	Info	
Operator Comment	P.O. Number	Present	Flow Control	Camera

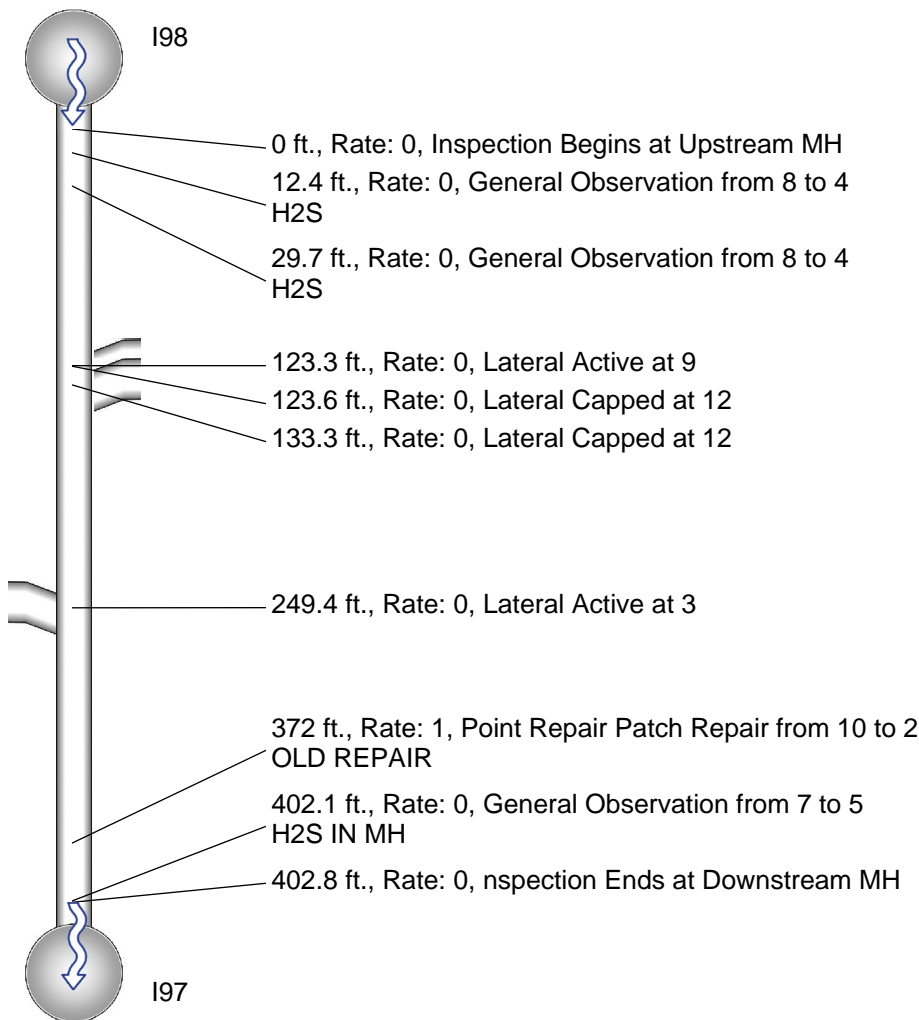
Pipe ID <b>I98</b>	City	Street <b>1300 E</b>	Shape	Map #1	Basin
<b>US Manhole</b> <b>I98</b>	Section Length <b>118.763</b>	Year Laid	Material <b>CON</b>	Section Type	
<b>DS Manhole</b> <b>I97</b>	Inspected Length <b>402.8</b>	Year Renewed	Depth US <b>14</b>	Depth DS	Joint Leng... Diameter <b>18</b>

Cleared		Situation		Reason	
Date <b>20181207</b>	Clean Date	Weather		Remark	
Start Time <b>13:24</b>					
Operator <b>CODY</b>	Customer	Truck <b>4161</b>	Inspection Dir. <b>Downstream</b>	Info	
Operator Comment	P.O. Number	Present	Flow Control	Camera

\* = clock positions adjusted automatically for reverse inspection

Scale: 1:1200
