### Left Plot w/ Pics

Pipe ID <b>F15</b>	City	Street <b>MURRAY HOLLADAY RD</b>	Shape	Map #1	Basin
<b>US Manhole</b> <b>F15</b>	Section Length <b>120.628</b>	Year Laid	Material	Section Type	
<b>DS Manhole</b> <b>F14</b>	Inspected Length <b>418.5</b>	Year Renewed	Depth US <b>N/A</b>	Depth DS	Joint Leng... Diameter <b>18</b>
Cleaned	Situation		Reason		
Date <b>20181015</b>	Clean Date	Weather		Remark	
Start Time <b>13:01</b>					
Operator <b>STEVEN</b>	Customer	Truck <b>4165</b>	Inspection Dir. <b>DOWNSTREAM</b>	Info	
Operator Comment	P.O. Number	Present	Flow Control	Camera

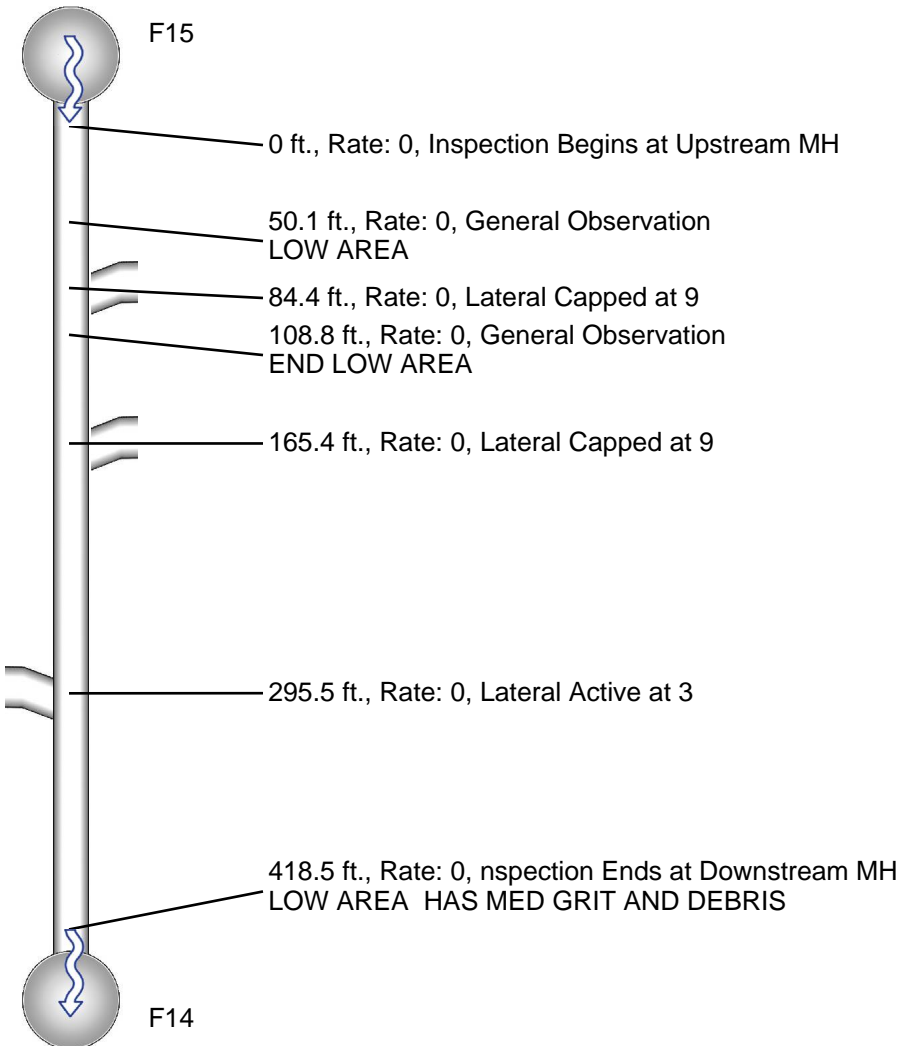
Scale: 1:1200

Pipe ID <b>F15</b>	City	Street <b>MURRAY HOLLADAY RD</b>	Shape	Map #1	Basin
<b>US Manhole</b> <b>F15</b>	Section Length <b>120.628</b>	Year Laid	Material	Section Type	
<b>DS Manhole</b> <b>F14</b>	Inspected Length <b>418.5</b>	Year Renewed	Depth US <b>N/A</b>	Depth DS	Joint Leng... Diameter <b>18</b>

Cleared		Situation		Reason	
Date <b>20181015</b>	Clean Date	Weather		Remark	
Start Time <b>13:01</b>					
Operator <b>STEVEN</b>	Customer	Truck <b>4165</b>	Inspection Dir. <b>DOWNSTREAM</b>	Info	
Operator Comment	P.O. Number	Present	Flow Control	Camera

\* = clock positions adjusted automatically for reverse inspection

Code: TIBU	0.0 ft.					
Observation: Inspection Begins at Upstream MH							
Remarks:

Code: TGO	50.1 ft.					
Observation: General Observation							
Remarks: LOW AREA

Code: CLC	84.4 ft.	9				
Observation: Lateral Capped							
Remarks:

Code: TGO	108.8 ft.					
Observation: General Observation							
Remarks: END LOW AREA

Code: CLC	165.4 ft.	9				
Observation: Lateral Capped							
Remarks:

Code: CLV	295.5 ft.	3				
Observation: Lateral Active							
Remarks:

Code: TIED	418.5 ft.					
Observation: nspection Ends at Downstream MH							
Remarks: LOW AREA HAS MED GRIT AND DEBRIS
