Pipe ID N120-80	City	Street WANDER LN 2780 E	Shape	Map #1	Basin
US Manhole N120-80	Section Length 123.655	Year Laid	Material PRC	Section Type	
DS Manhole N120-48	Inspected Length 367.1	Year Renewed	Depth US 7	Depth DS	Joint Leng... Diameter 8
Cleaned	Situation		Reason		
Date 20181010	Clean Date	Weather		Remark	
Start Time 13:08					
Operator CODY	Customer	Truck 4161	Inspection Dir. Downstream	Info	
Operator Comment	P.O. Number	Present	Flow Control	Camera

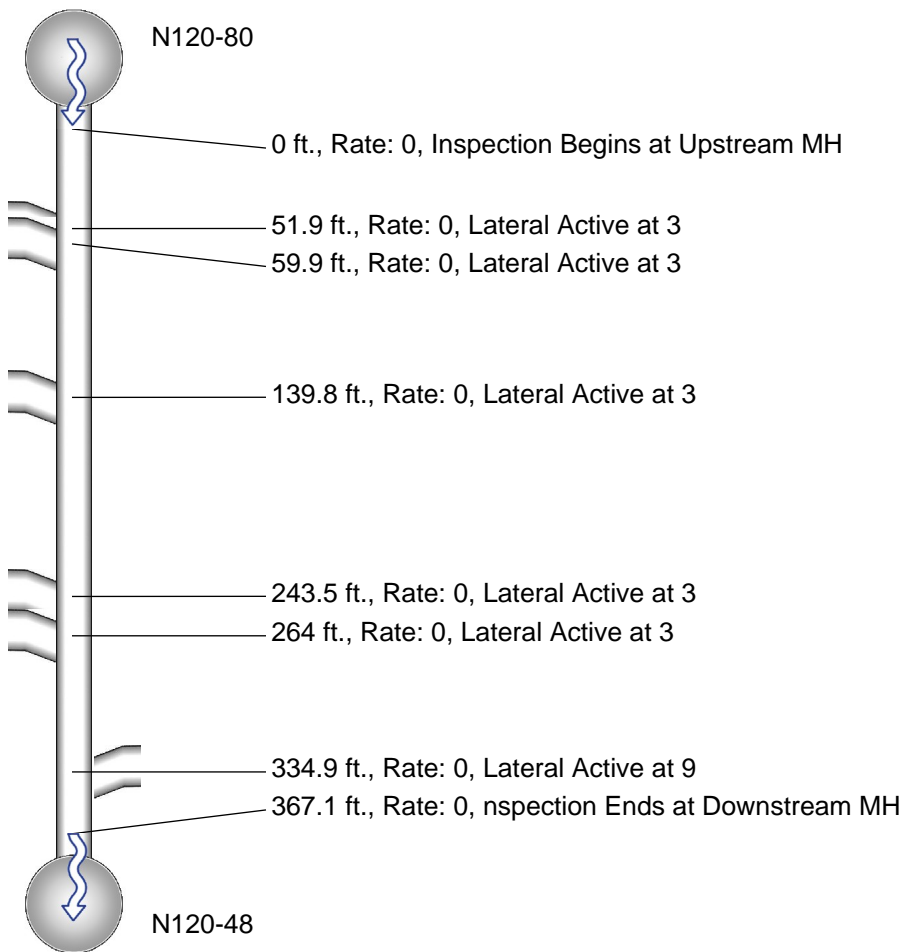
* = clock positions adjusted automatically for reverse inspection

Scale: 1:1200

Code: TIBU	0.0 ft.					
Observation: Inspection Begins at Upstream MH							
Remarks:

Code: CLV	51.9 ft.	3				
Observation: Lateral Active							
Remarks:

Code: CLV	59.9 ft.	3				
Observation: Lateral Active							
Remarks:

Code: CLV	139.8 ft.	3				
Observation: Lateral Active							
Remarks:

Code: CLV	243.5 ft.	3				
Observation: Lateral Active							
Remarks:

Code: CLV	264.0 ft.	3				
Observation: Lateral Active							
Remarks:

Code: CLV	334.9 ft.	9				
Observation: Lateral Active							
Remarks:

Code: TIED 367.1 ft.

Observation: nspection Ends at Downstream MH
