D33 TV Observations

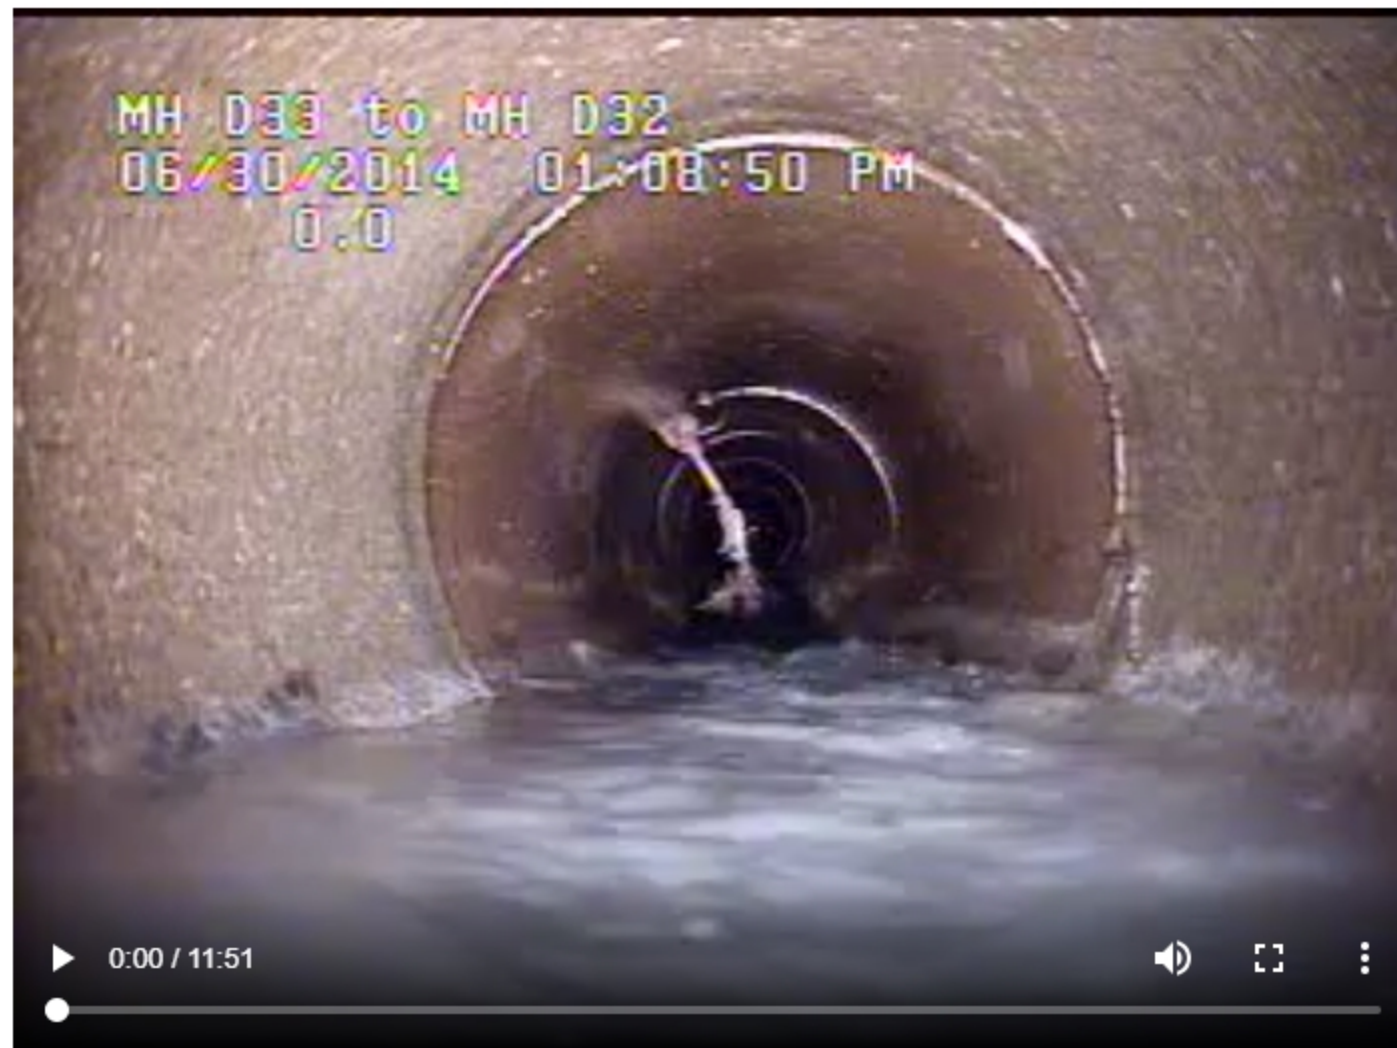
Footage	Digital Time	Clock From	Clock To	Code	Observation	Remarks
0	6			AMH	Manhole	OK
0	10			MWL	Water Level	
7	34	3	9	RFJ	Roots Fine Joint	
8	74	3		TF	Tap Factory	
20.1	107	4	8	RFJ	Roots Fine Joint	
27.7	129	3	4	RFJ	Roots Fine Joint	
40.3	168	8	2	RTJ	Roots Tap Joint	
43.8	186	9	3	RFJ	Roots Fine Joint

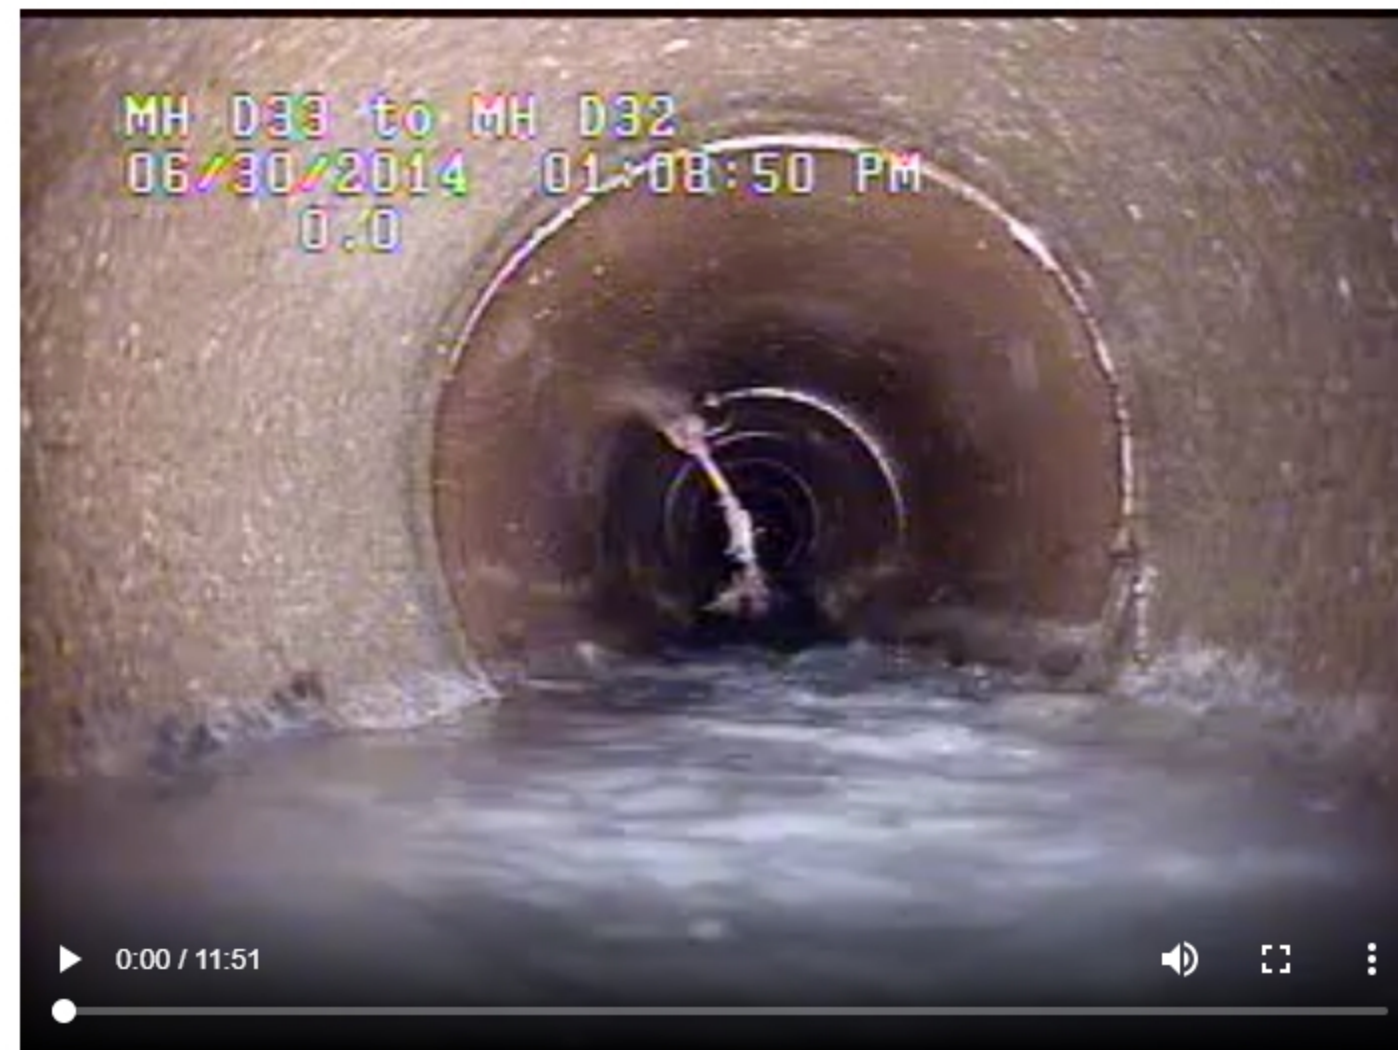
D33 TV Observations

43.8	186	9	3	RFJ	Roots Fine Joint	
46.6	240	8	1	RMJ	Roots Medium Joint	
47.5	270	3		TF	Tap Factory	
115.2	371	3		TB	Tap Break-in	
147.7	430	9	3	RBJ	Roots Ball Joint	
197.3	517	3		TF	Tap Factory	
251.6	605	3		TF	Tap Factory	
288.9	696			AMH	Manhole	MED ROOTS
